Historic Building Assessment for the Greenfield Meetinghouse

776 Forest Road, Greenfield, New Hampshire

Conducted for the Town of Greenfield

Mae H. Williams, Preservation Consultant & Misiaszek Turpin pllc

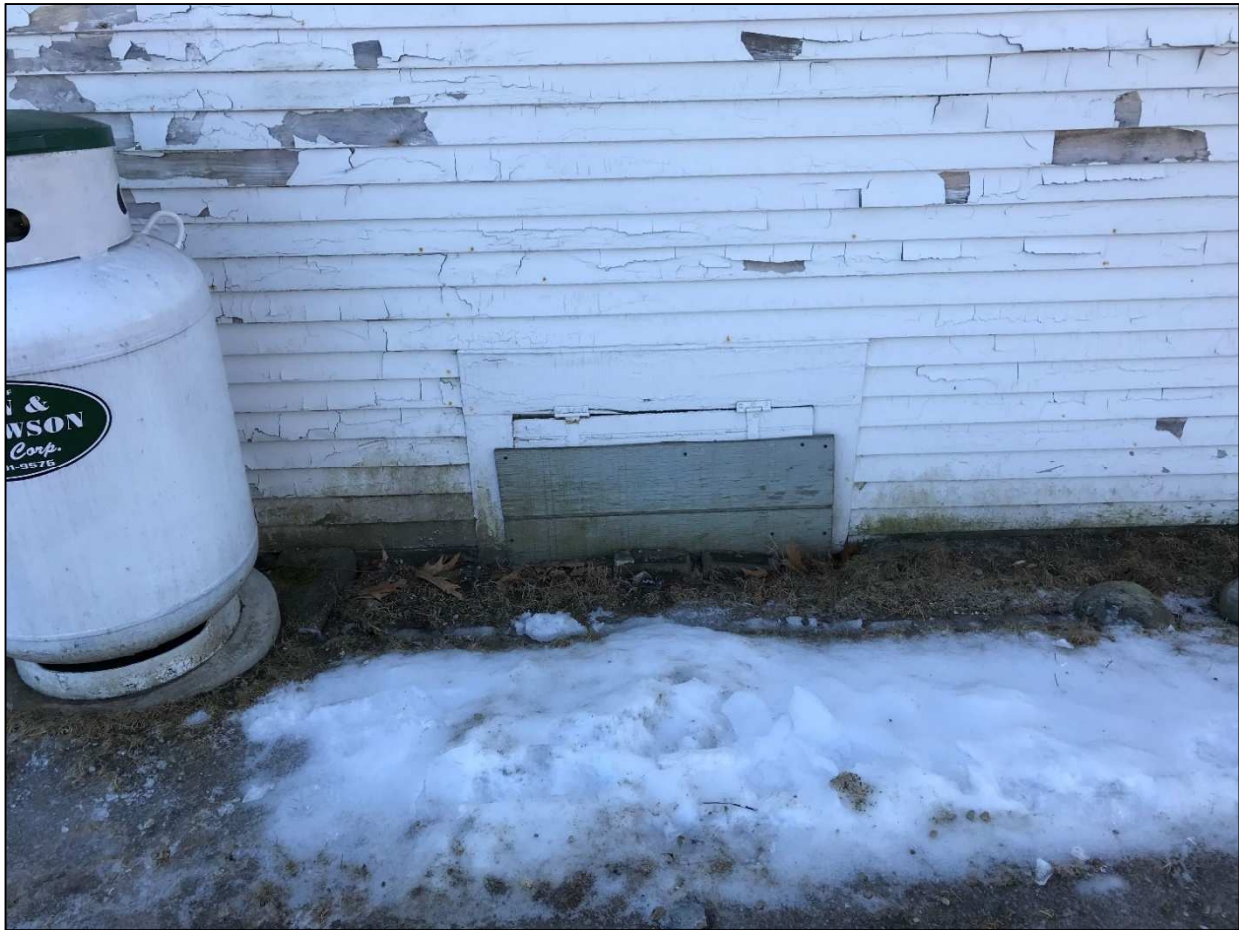
Figure III-5: Grade at the north elevation of the Meetinghouse has risen above the bottom clapboards

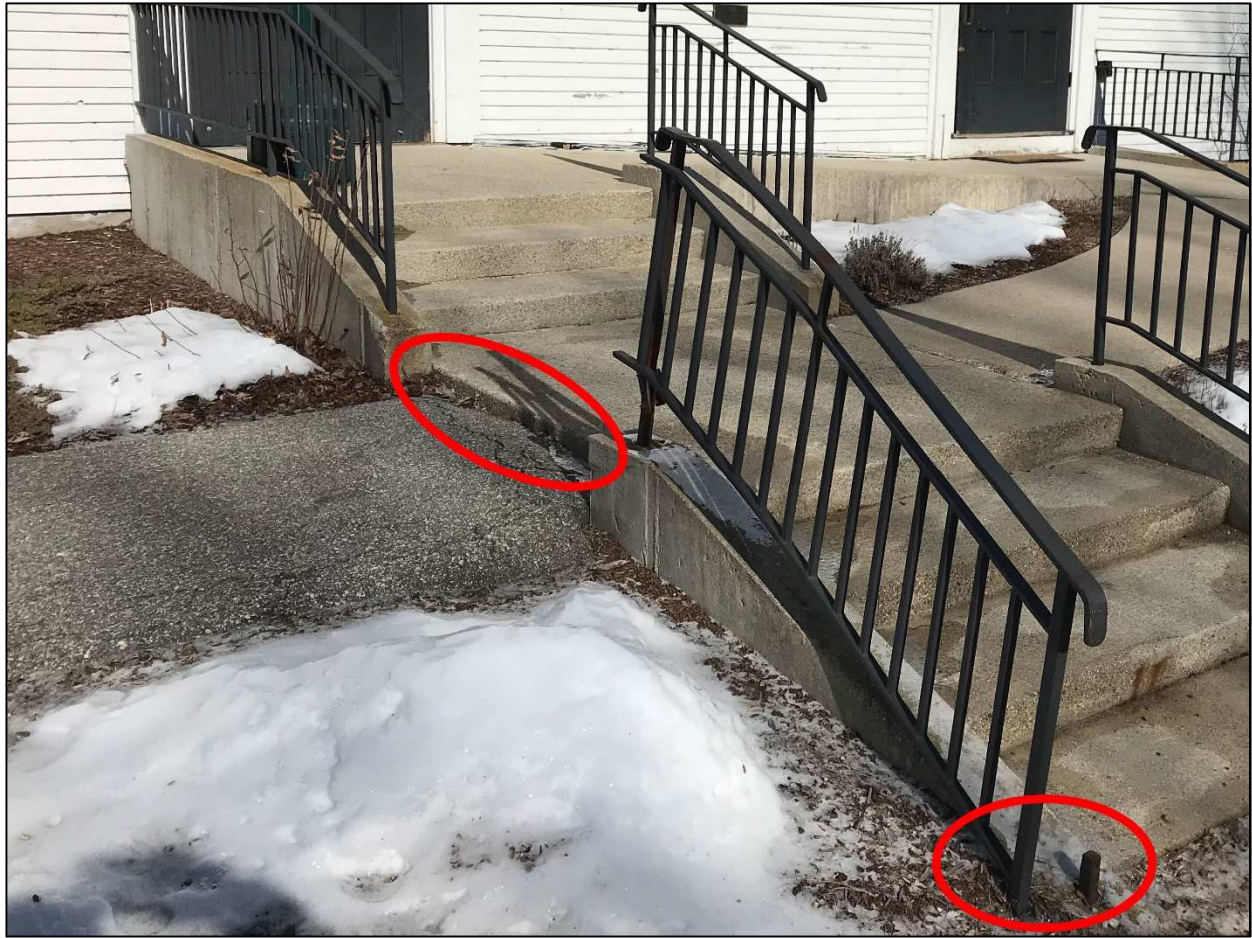
Figure III-6: Disconnected railing and lip at intersection between asphalt and concrete at ramp

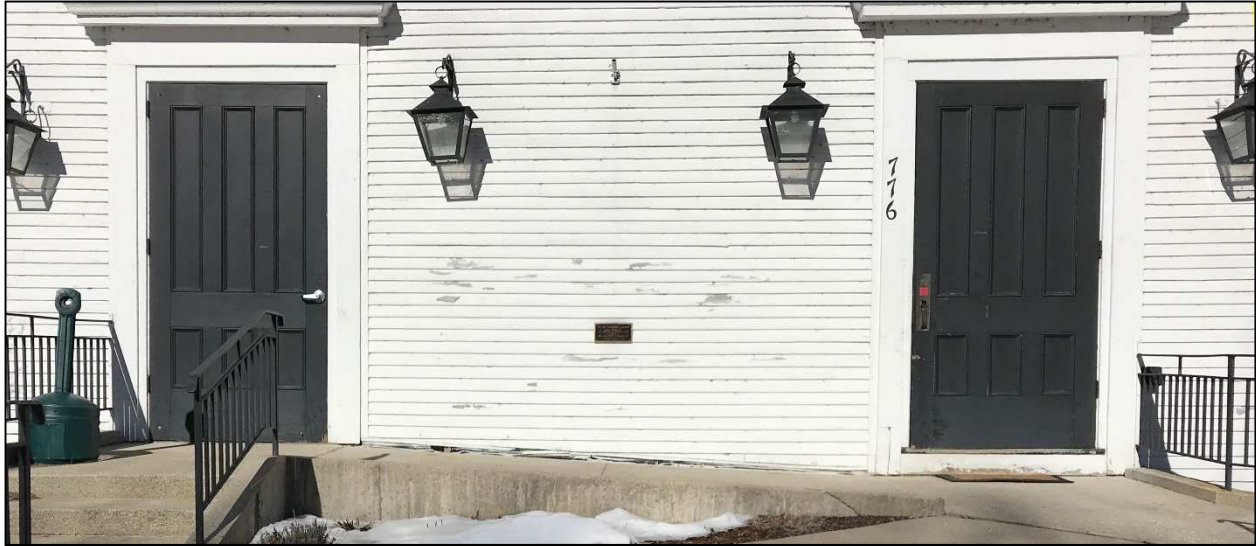
are in fair condition but show areas of paint chipping and wear, grime, and some splintering and cracking of the boards. To the sides of each door is hung a black electrical lantern providing illumination to the entrance way. These are hung from iron hooks mounted to the building.

Figure III-7: Entry to Greenfield Meetinghouse

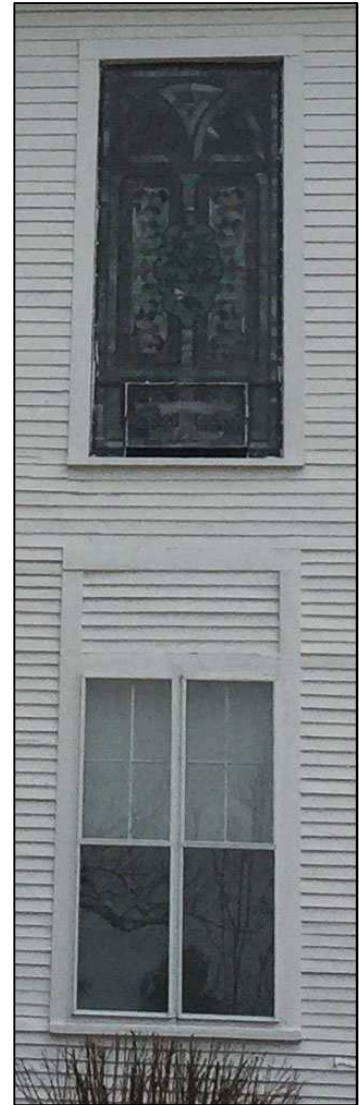
Located directly above each main level window is a large stained-glass window at the upper level (Figure III-12). These windows were installed in 1905 and are protected by plexiglass panels. Visible through the southernmost window is the modern floor construction of the loft level. The windows themselves are intact, but failure of the glass is imminent: each unit has minimal deflection, some cracked or broken glass, cracks within the perimeter leading, and a majority of the tie wires have pulled away, rendering the horizontal support bars useless. The storm windows installed

Figure III-12: Side-elevation windows

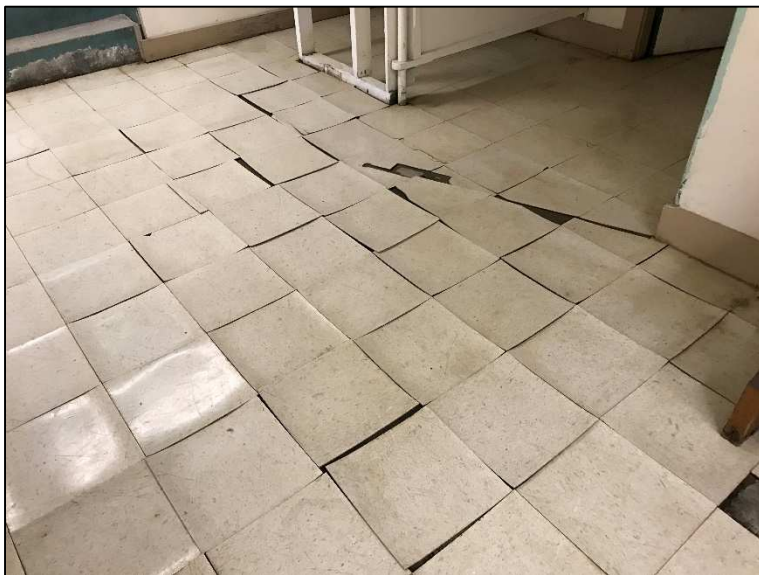
Figure III-18: Tile floor of the Community Room with moisture damage

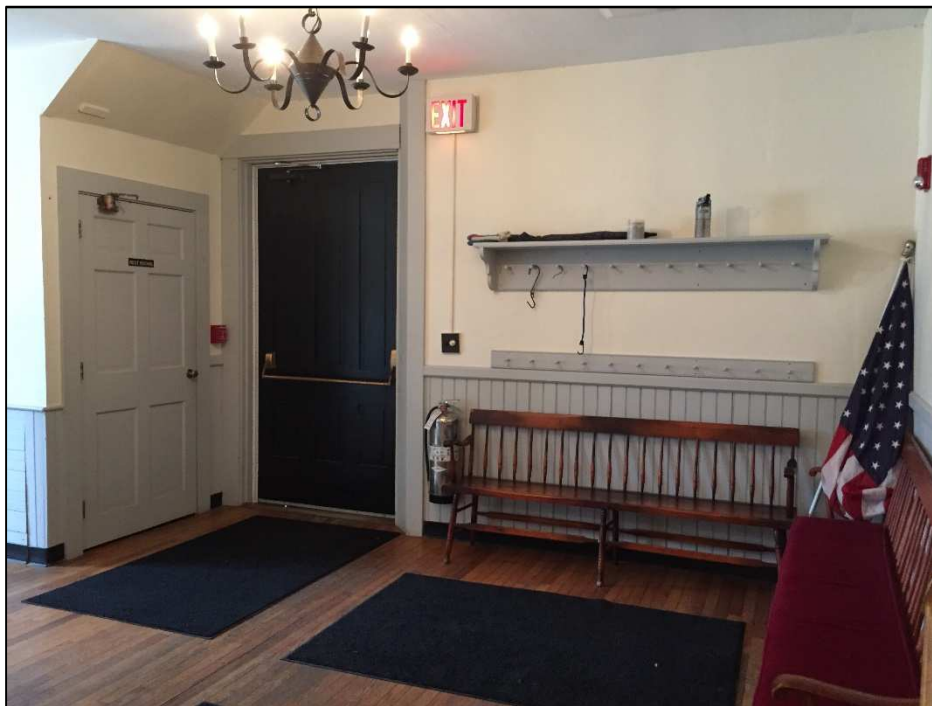
The Foyer is generally in good condition; the wainscoting on the north, west and south walls has a wide chair rail, vertically oriented beadboard and a modern vinyl baseboard (Figures III-34 & 35). On the eastern and southern walls of the enclosed

Figure III-35: Main entry door into the Foyer

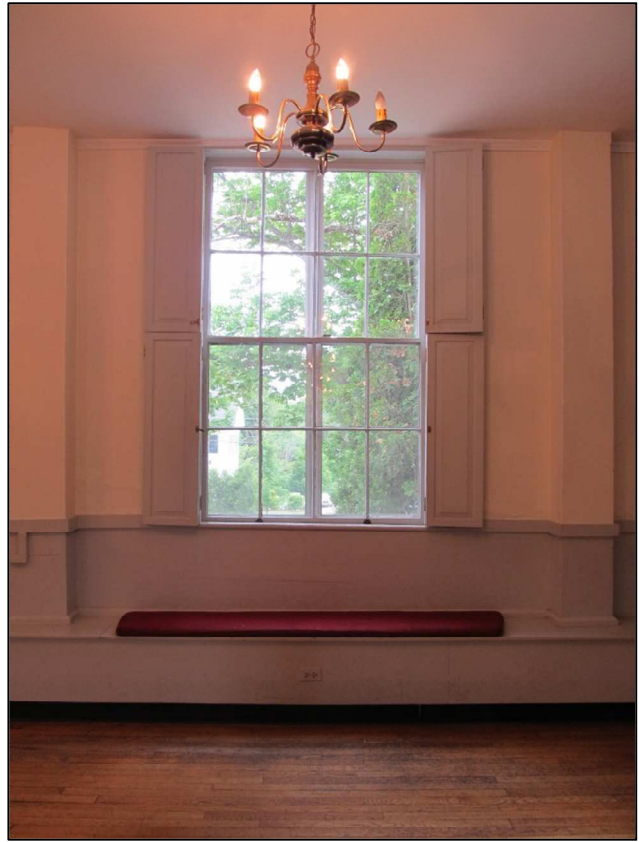
The built-in benches along the east and west sides of the Meeting Hall are in very good condition, although the improperly sized cushions are dirty, stained and have areas of wear (Figure III-40). Electrical outlets are regularly spaced on the vertical face of the bench. The plaster wall meets the top of the benches, as no wainscoting is present on these walls. Four eight-over-eight windows are located in the Meeting Hall along the eastern and western walls, providing ample levels of natural

Figure III-40: Meeting Hall benches & windows

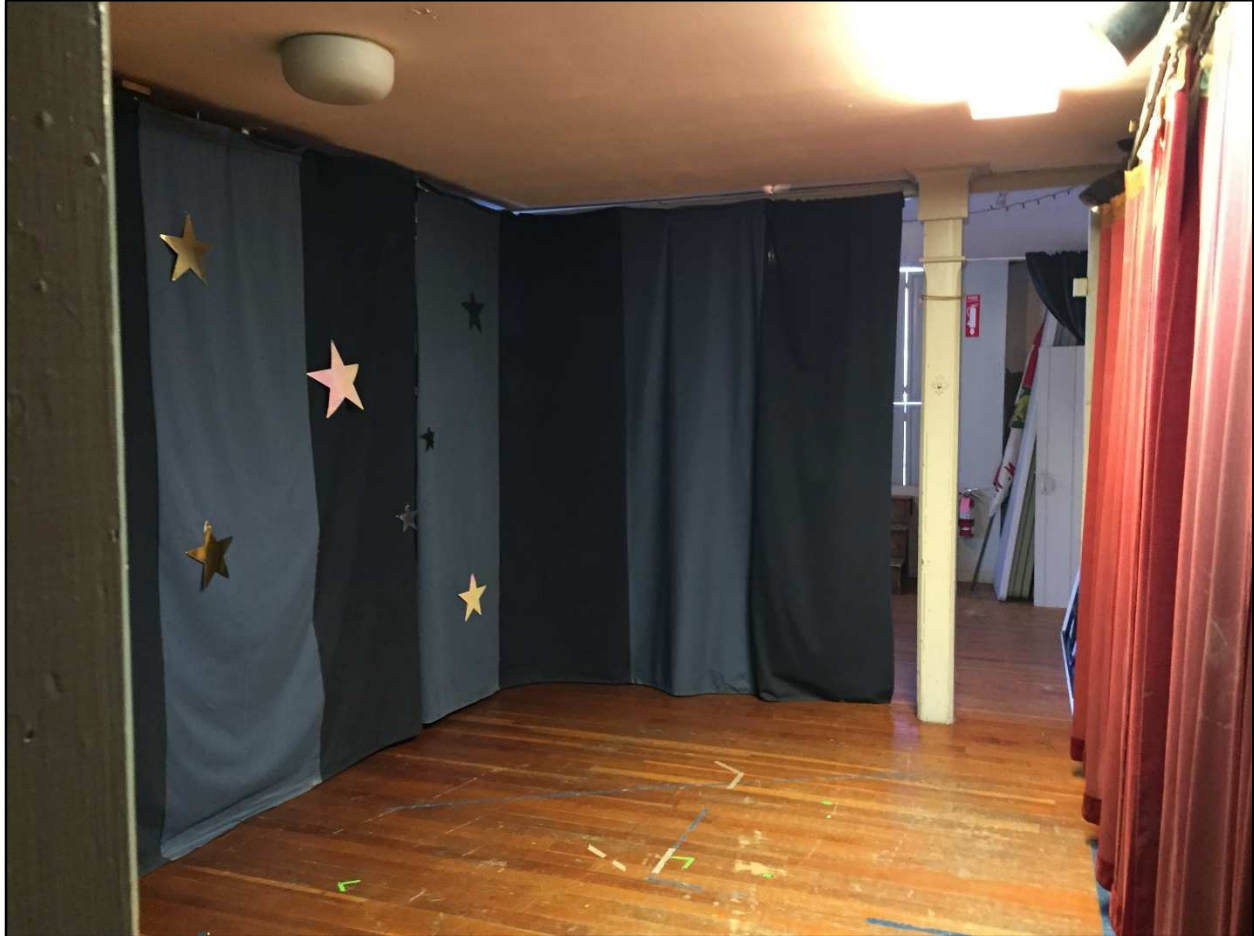
The entire northern portion of the main level is dedicated to the Stage (105), which is elevated approximately two-feet above the main level floor. The thin-board wooden floor of the Stage is in fair

Figure III-41: Stage looking northeast
