# **Historic Building Assessment for the Greenfield Meetinghouse**

**776 Forest Road, Greenfield, New Hampshire**

Mae H. Williams, Preservation Consultant & Misiaszek Turpin pllc

February 2019

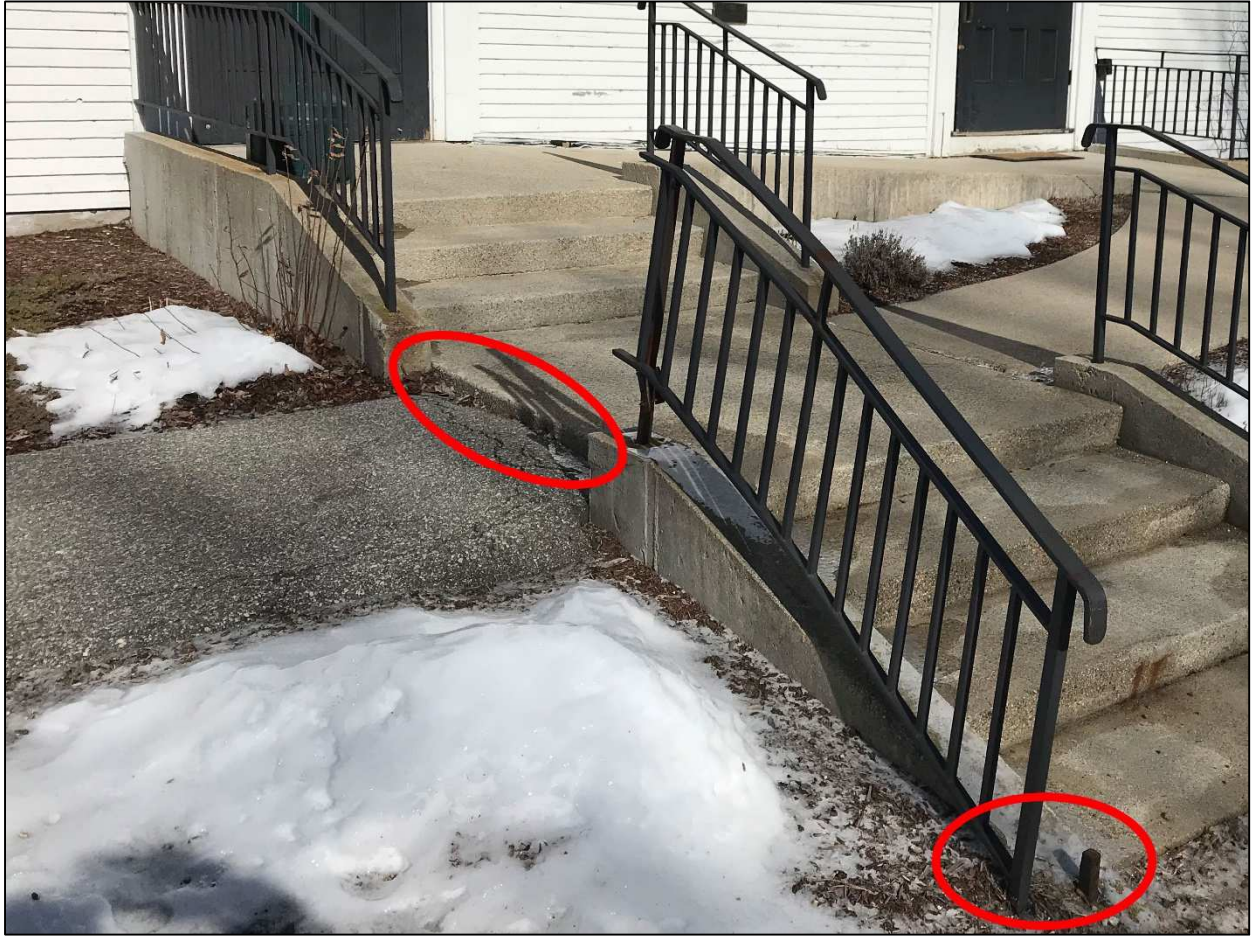
*Figure III-3: Disconnected railing and lip at intersection between asphalt and concrete at ramp*

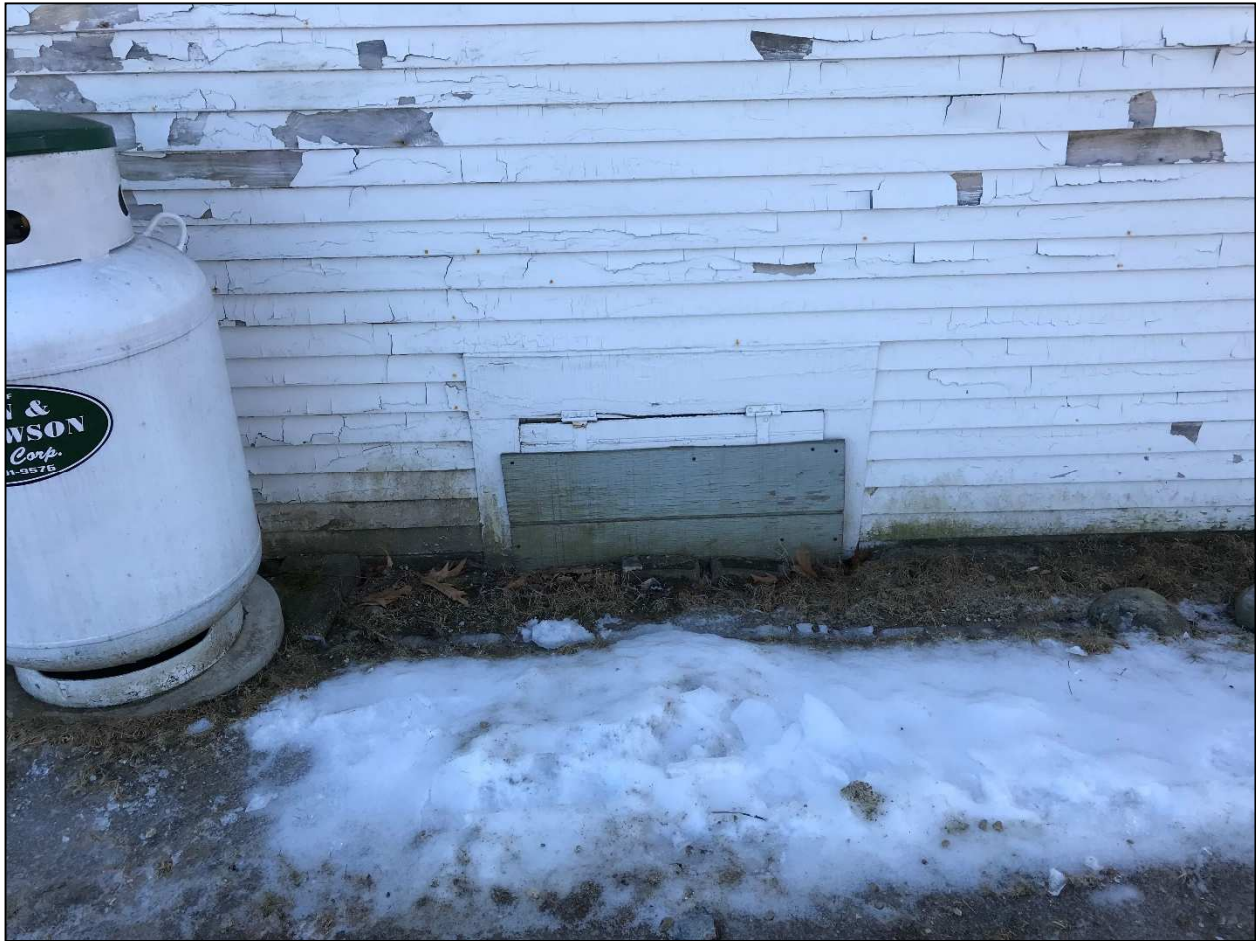
however, these surfaces express extensive areas of paint peeling. In several areas at the base of the building,

*Figure III-4: Grade at the north elevation of the Meetinghouse has risen above the bottom clapboards*

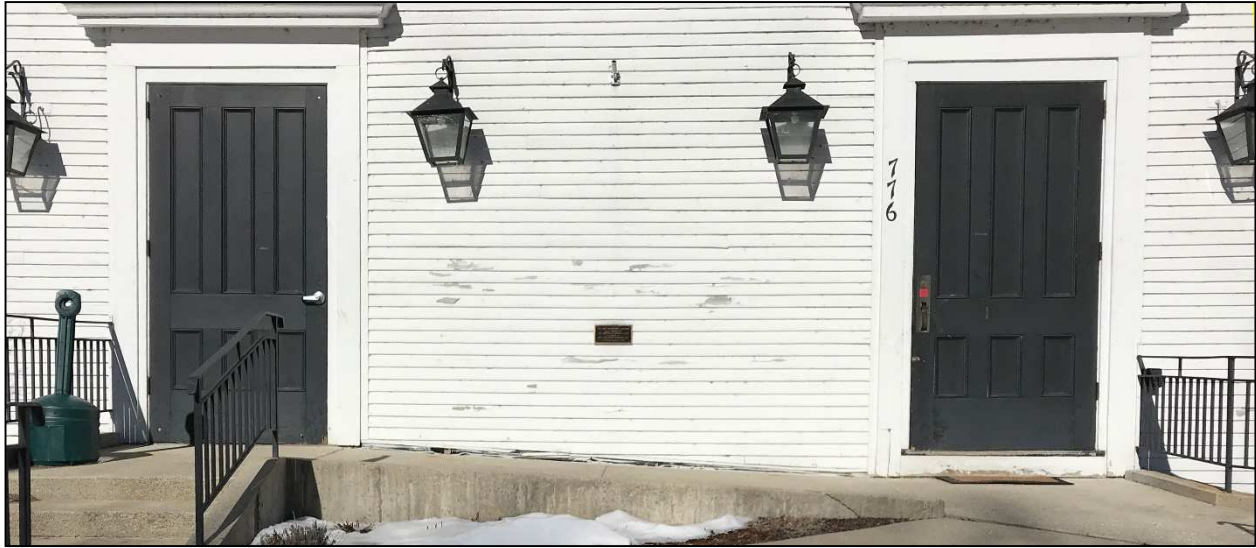
causes issues with closing them and securing the facility. The door casing and header for the doors are in fair condition but showcase areas of paint chipping and wear, grime, and some splintering and cracking of the boards. To the sides of each door is hung a black electrical lantern providing illumination to the entrance way. These are hung from iron hooks mounted to the building.

*Figure III-5: Entry to Greenfield Meetinghouse*

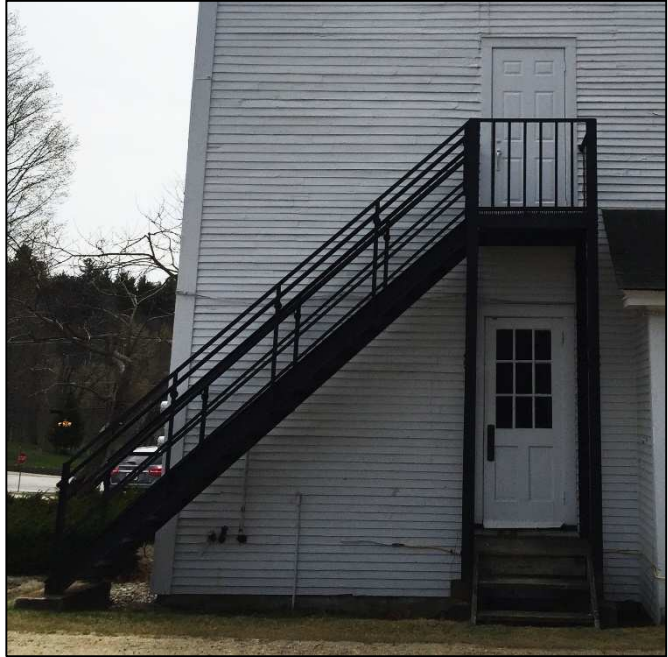
The northern façade of the building has two egress doors. A half-lite wooden door with two recessed panels, provides a second means of egress from the stage located on the main level (Figure III-7). The door is in fair condition, with areas of paint chipping, and broken weatherstripping. Flat-stock casing with a simple bead detail at the header surround the door and has areas of paint chipping with an unfinished wooden threshold that is in need of repair. An unfinished wooden landing with two wooden treads, provides access from the stage to the lower exterior grade, and is poor

*Figure III-7: Doors and fire stair at north elevation of Greenfield Meetinghouse*

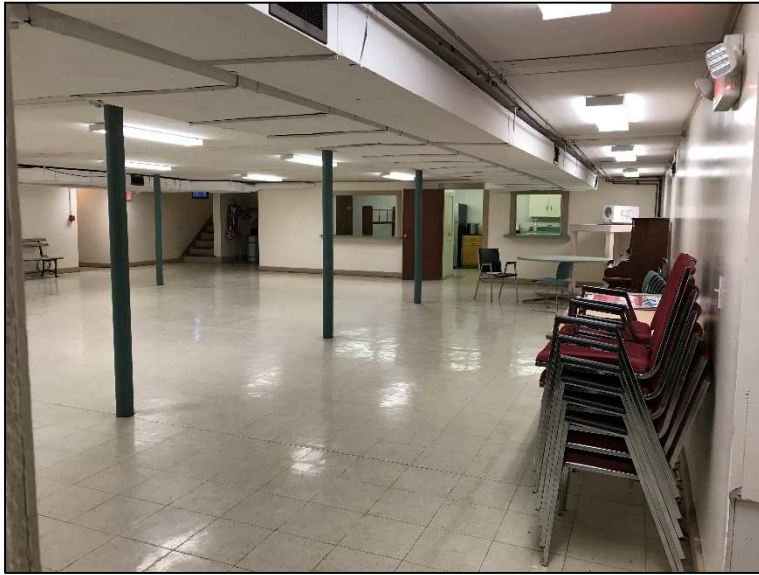
*Figure III-15: Community Room looking south*

spots and areas with no artificial lighting at all. Mechanical duct work is suspended from the low ceiling, generating zones of lower vertical clearance (Figure III-15). These ducts are in fair condition and have been painted white to match the ceiling. The steel beams located within the ceiling plane have minimal exposure into this lower level; however, what is exposed has been painted white to match the ceiling and has areas of rust staining through the paint. Three windows are located within the Community Room; one in the northwest corner by the restrooms, the second located centrally on the western wall, and the third located within the stairwell in the southeast corner. The central window has since been infilled with a vent, so no glazing is present.

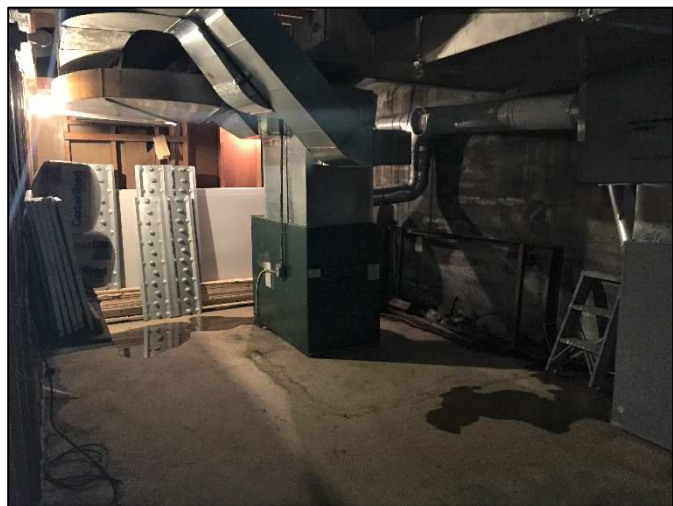
The mechanical room is in good condition and is accessed via a two-panel wooden door with modern hardware. Although affected by the water leakage from the northern wall, the space remains in good condition with very limited areas of damage. The concrete slab remains exposed on the floor within this room, with no vinyl tiles. The southern and western walls of the space are exposed-stud walls, with portions of gypsum board walls enclosing the storage room to the east. Both the northern and eastern walls are the concrete foundation walls (Figure III-18). Exposed floor joists from the elevated

*Figure III-18: Mechanical Room*

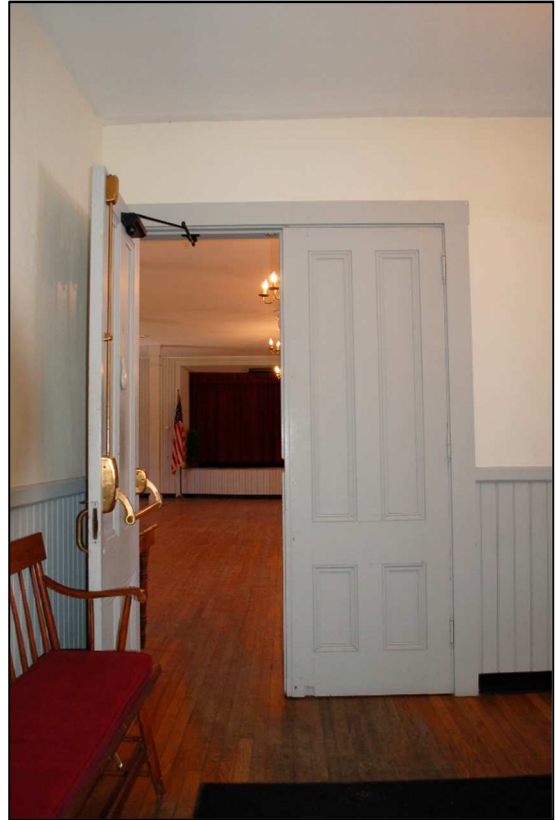
The two four-panel wooden doors between the Foyer and the Meeting Hall are in good condition (Figure III-34). In a similar style to

*Figure III-34: Meeting Hall entry doors*

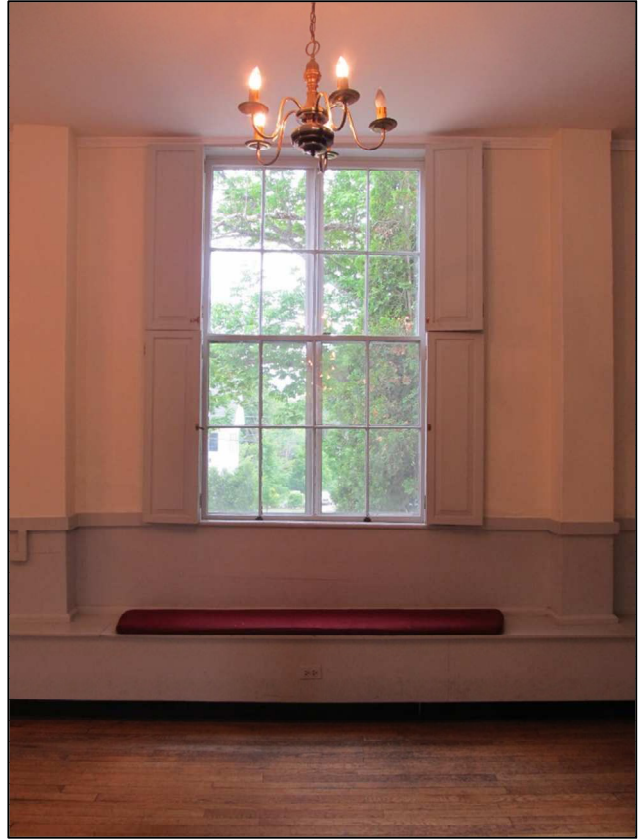
The built-in benches along the east and west sides of the Meeting Hall are in very good condition, although the cushions are in need of replacement (Figure III-38). Electrical outlets are regularly spaced on the vertical face of the bench. The plaster wall meets the top of the benches, as no wainscoting is present on these walls. Four 8/8 windows are located in the Meeting Hall along the eastern and western walls, providing ample levels of natural light to the space. In general, these windows are in good condition, each with an exterior storm window that is under-performing in energy efficiency. The northeastern window within the space has some minor damage and has a clear plastic covering installed on the interior. Each window has an interior set of bi-folding shutters (Figure III-38). Each shutter functions properly;

*Figure III-38: Meeting Hall benches & windows*

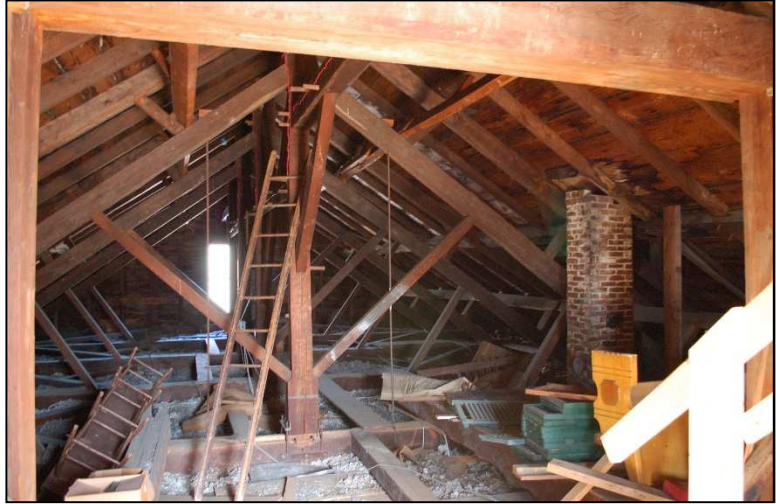
The attic level of the Greenfield Meetinghouse is in fair condition (Figure III-75). The single access point into the Attic is via the hatch in the ceiling of the Choir Loft at the southern end of the building. Within the central zone of the Attic, a simple floor has been constructed upon which staircases and ladders are installed providing access to the Clock Room and Bell Tower above. The entire volume is

*Figure III-75: Greenfield Meetinghouse attic, facing northeast*

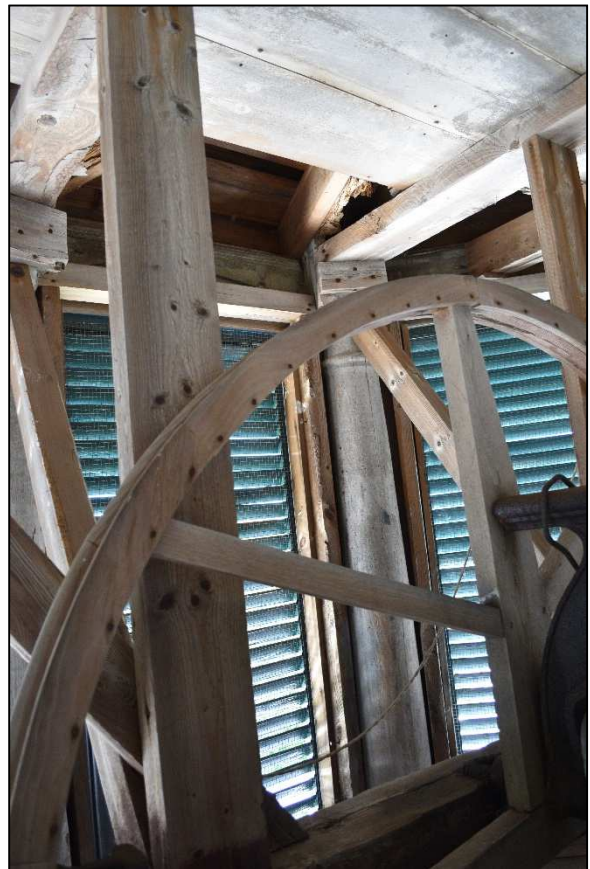
Figure III-87: Rotted beams at Lantern
