Historic Building Assessment for the Greenfield Meetinghouse

776 Forest Road, Greenfield, New Hampshire

Conducted for the Town of Greenfield

Mae H. Williams, Preservation Consultant & Misiaszek Turpin pllc

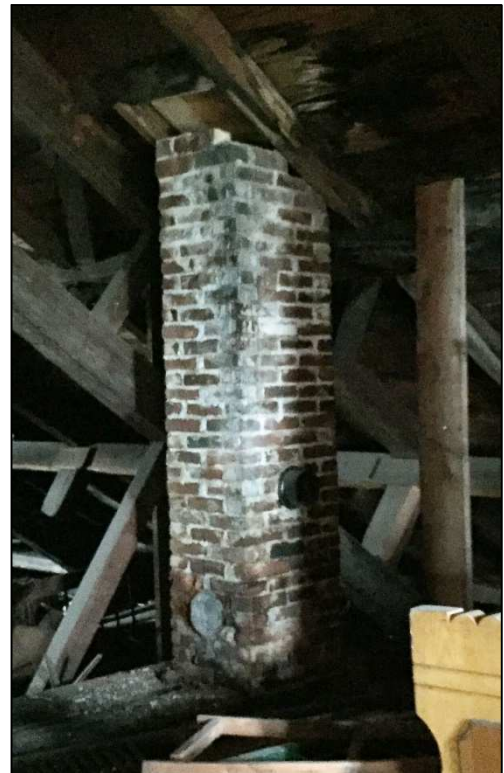
A partial interior brick chimney is visible at this level, just inside of the east wall, at the northern edge of the south bay (Figure II-53). The chimney has been disassembled to below the roof level. The wood around the chimney opening is very discolored due to historic water infiltration and leaching of creosote. The brick is not uniform in shape or composition and appears to have been hand made. The brick is badly spalled,

Figure II-53: Chimney in attic

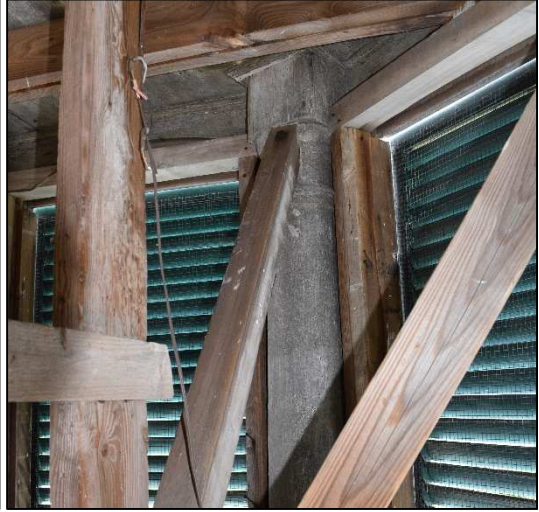
There is a very cramped, octagonal room around the bell at the belfry level of the Meetinghouse tower. The bell and bell mechanisms take up almost all of the small room that was created when louvered panels were installed between the eight corner columns that support the lantern above. Historically, this level was open to the outside, with simple rounded columns supporting each of the eight corners of the octagonal lantern (Figure II-58). Around the turn of the 20th century, large louvered panels were added between the columns in an effort to keep the elements away from the bell and keep birds out of the interior space, giving the belfry its current exterior appearance (Figure II-59). The interior of the louvered panels is covered with hardware cloth, preventing birds from reaching the interior of the belfry. The curved columns sit directly on top of the leaded roof of the bell tower. Square wooden cushions adorn the top of the columns, and remnants of delicately curved decorative trim between the columns can be seen at the roofline (Figure II-60). The columns and base of the lantern above were once painted a light grey or white. When the belfry and steeple were repaired in 1982, many additional modern dimensional lumber supports were added to the belfry level. Additional support was given to the bottom of the lantern with some damaged members sistered with new boards and other boards simply added to give the bottom of the lantern rigidity. Additional braces were added between the bell and the columns, crisscrossing the belfry, and creating a lot of modern visual distraction from the historic space (Figure II-61).

Figure II-61: Modern bracing

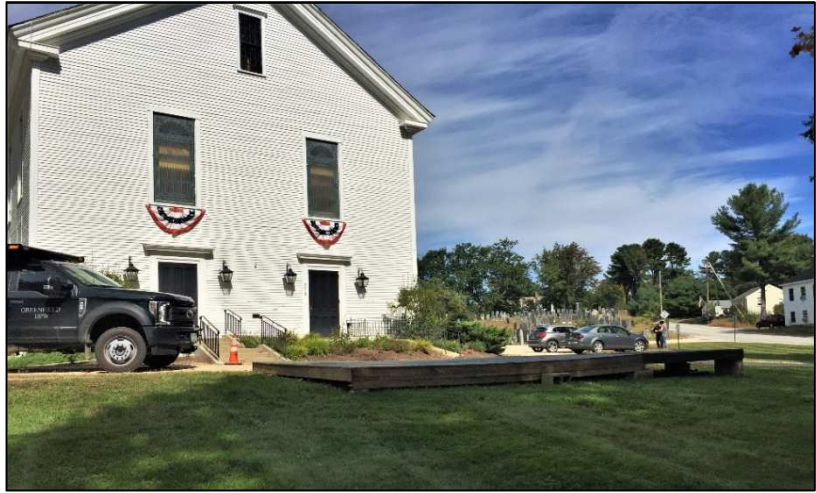
Cookoff. These events bring people together for gatherings with the historic Meetinghouse as the backdrop. Today, a temporary stage is constructed (Figure III-3) at the start of each season, from which performances take place. Electrical power is fed to the stage from extension cords leading from inside the Meetinghouse. The dirt drive circling the building separates the Common from the Meetinghouse, undermining the close relationship of the Meetinghouse and the Common as one community gathering space.

Figure III-3: Temporary Stage constructed at the northern edge of the Common

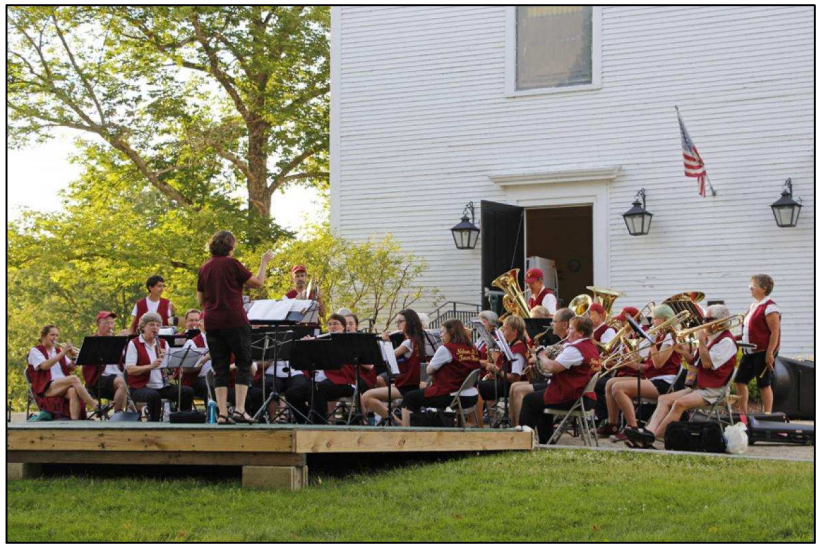
Although functioning and meeting the basic needs of the program and performance, the temporary stage does not provide complete stability, safety or flexibility (Figure III-4). Additionally, it requires annual labor and materials to reconstruct and install, and has the general appearance of something temporary. The dimensional lumber, plywood and CMU block supports do not provide aesthetic continuity with the beauty of the Common and the Meetinghouse and evoke a sense of temporary cultural programming.

Figure III-4: Performance held as part of "Music on the Common"

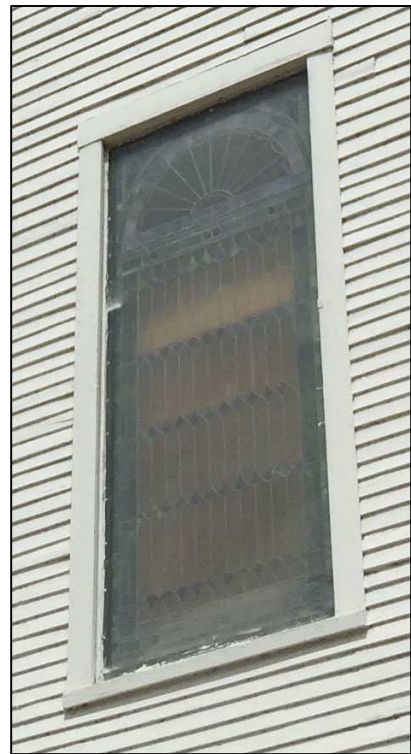
Located directly above each door is a large stained-glass window, installed in 1905, in front of which a plexiglass panel has been installed (Figure III-8). Visible through each window is the modern floor construction of the loft level. The windows themselves are intact, although they are in need of immediate restoration work, repair and protection. The storm windows installed at the exterior of each stained-glass window are in poor condition and appear to be potentially causing damage to the window leading with captured moisture between the surfaces. Flat-stock casing, sill and header surround the stained-glass window, and from visual inspection from ground level, appear to be in fair condition. Centered within the peak of this southern gable face is an historic wooden, sixteen-over-sixteen double-hung window accessed from the attic of the Meetinghouse. A screen is installed on the exterior. The window is in fair condition. Articulated trim and a flat-stock sill surround this window, with a more detailed header corresponding with the headers of the entrance

Figure III-8: Upper level stained glass window with exterior storm window

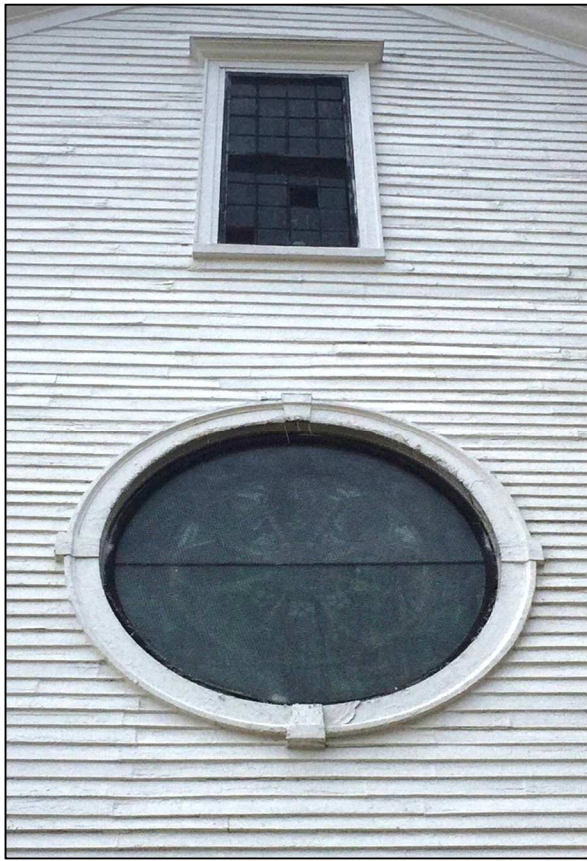
Figure III-10: Windows at north elevation

Centered on the north façade and located behind the altar within the sanctuary is a single, circular stained-glass rose window, installed in 1905 along with the ten other rectangular stained-glass windows (Figure III-10). The window is intact but has areas of minor deflection, damage to the perimeter leading and broken tie wires. Circular trim casing surrounds the window with a simple edge molding and four decorative keystones located at each quadrant. From ground-level inspection and photography, this woodwork appears to be in fair condition, with areas of paint peeling and some cracking. Unlike the other stained-glass windows, this unit has no storm window installed on the exterior; rather, a mesh screen has been installed that now exhibits perimeter fraying. Centered within the peak of this northern gable face is an historic wooden, sixteen-over-sixteen double-hung window accessed from the attic of the Meetinghouse. The window is in poor condition, with multiple panes of glass and areas of putty missing and extensive paint failure. Articulated trim and a flat-stock sill surround this window, with a more detailed header corresponding with the headers of the main entrance doors. From ground-level inspection and photography, these elements appear to be in fair condition.

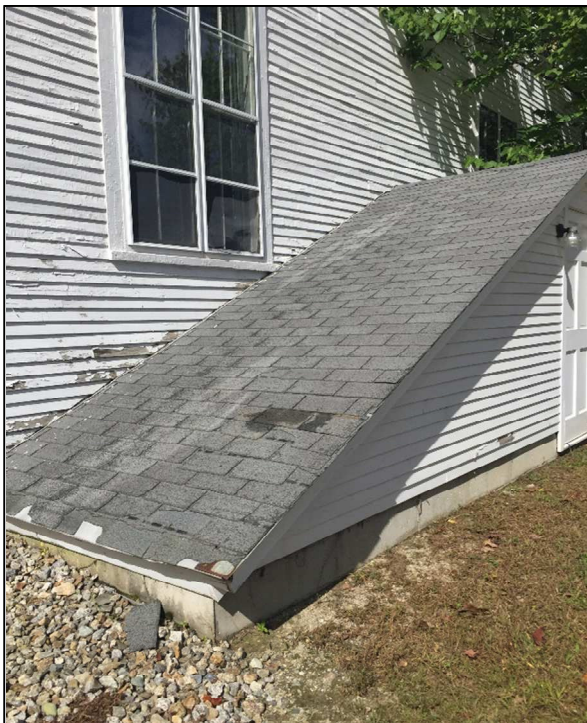
Figure III-11: Asymmetric, eastern egress volume

volume has a full-height wall to the north supporting an asymmetric peaked roof with its long leg extending the full length of the stair enclosure and resting on the concrete foundation wall (Figure III-11). A wooden door with six recessed panels is located on this volume's eastern face, has no exterior hardware and is in fair condition; however, is difficult to close and secure the space. Flat-stock trim surrounding the door is in fair condition with paint chipping. There is a simple light fixture mounted to the exterior of the volume, illuminating the area of egress. Due to the age of this fixture, it is not energy efficient and does not provide adequate levels of egress illumination.

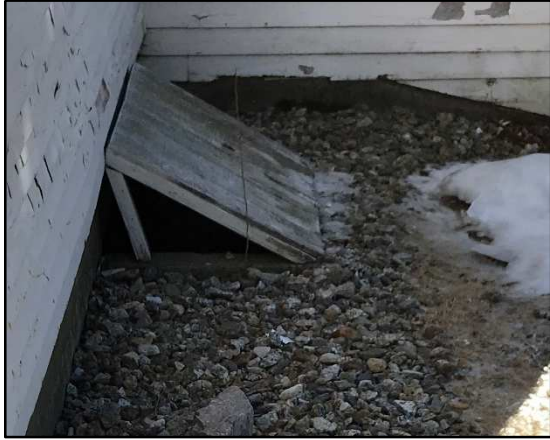
Located along the foundation are two window wells with windows to the lower level (Figure III-13). These concrete wells have separated from the building's foundation at some locations and are covered by

Figure III-13: Typical window well & cover

temporary sloped covers, constructed from modern dimensional lumber of various materials from horizontal clapboards to planks. These sloped covers are in various conditions, each exhibiting water damage and paint spalling.

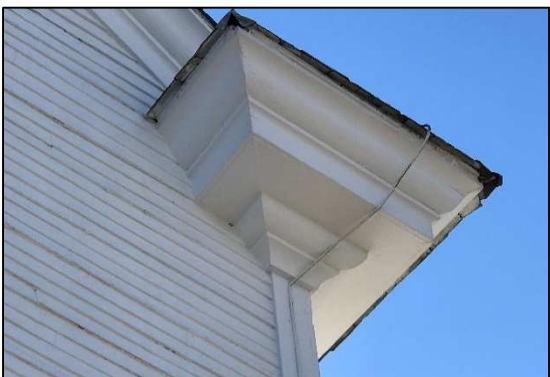
Figure III-15: Roof fascia & soffit detail

molding at the narrow fascia, flat soffit, bed molding and narrow frieze that are in fair condition, with areas of peeling paint and grime (Figure III-15).

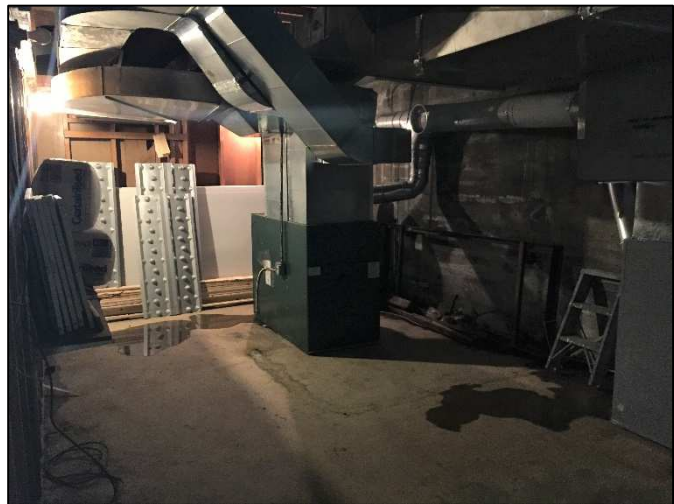
Figure III-20: Mechanical Room

The mechanical room is in good condition and is accessed via a two-panel wooden door with modern hardware. Although affected by the water leakage from the northern wall, the space

remains in good condition with very limited areas of damage. The concrete slab remains exposed on the floor within this room, with no vinyl tiles. The southern and western walls of the space are exposed-stud

walls, with portions of gypsum board walls enclosing the storage room to the east. Both the northern and eastern walls are the concrete foundation walls (Figure III-20). Exposed floor joists from the elevated stage constitute the ceiling plane for the room. The wall and ceiling assembly do not meet current fire codes. This space has low-level lighting.

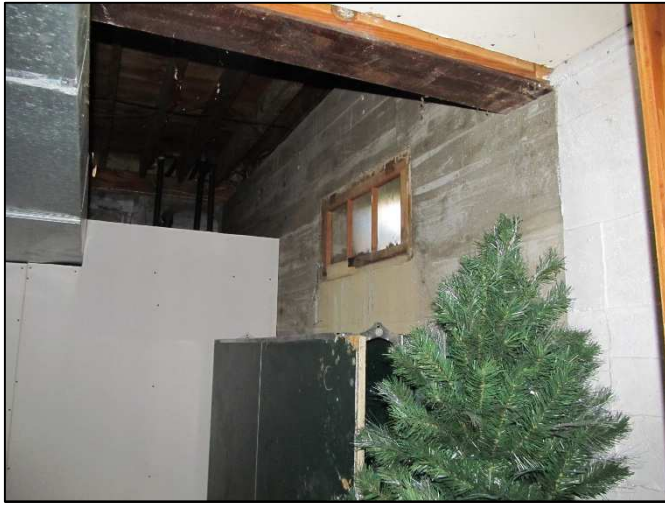
Figure III-21: Storage Room, exposed structure & window

A four paneled wooden door with mis-matched hardware provides access to the storage room; however, this door has been removed from its hinges and simply rests within the opening. This room is partially finished, with shelving along the exposed eastern foundation wall. The vinyl tile flooring of the Community Room continues through this space and is in fair-to-good condition. Lighting fixtures within this space are minimal in number and no longer have electricity running to them. There is evidence of some water damage throughout the space, and the walls do not have baseboards; however, the gypsum board walls are new within the past two years. The mechanical ductwork that runs through the Community Room, continues through this space; however, the floor joists and structural steel beam are fully exposed in a portion of the space (Figure III-21). An original ca. 1947 window is located on the eastern wall of this space, with sash and glazing intact (Figure III-21).

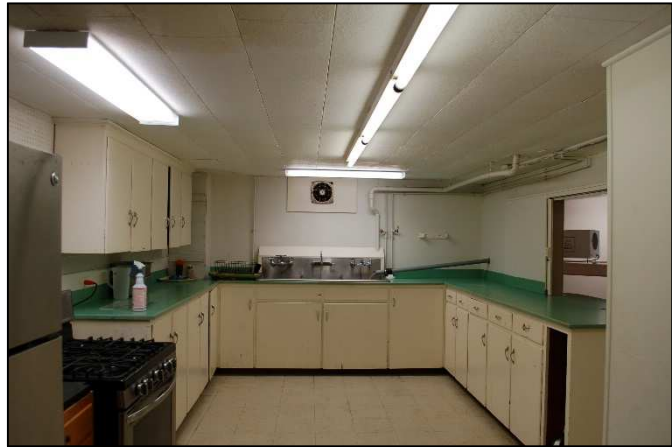
Figure III-22: West wall of the kitchen

the entire floor, and is located in the southwestern corner of the Community Room. This then drains into the sink in the kitchen via an exposed hose and performs adequately (Figure III-22). The concrete floor throughout the space is finished with 12"x12" beige vinyl tiles that are in fair-to-poor condition, with areas of water damage, wavy spots and worn-out sections in higher traffic areas. Water seeps through the northern foundation wall due to the exterior grade conditions, most notably after large, heavy storms. Recently, the entire northern structural bay within the Community Room had standing water that stripped the backing glue from the vinyl tiles, causing them to curl and shift out of place (Figure III-18).

chase is in fair condition, but there are visible indications that this has been opened-up in the past. A single window opening is located above the sink; however, glazing is no longer present within the opening, as it has been filled with a vent (Figure III-22).

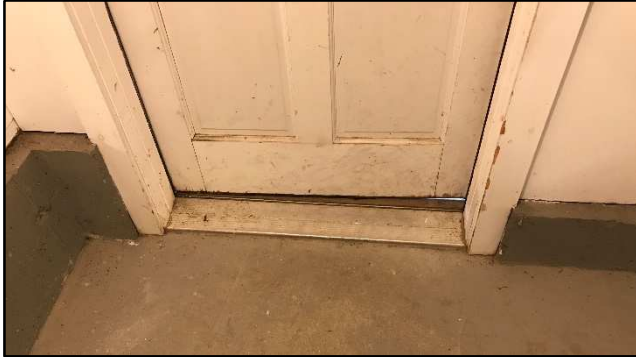
Figure III-28: Egress door damage

staining (Figure III-30). Similar to the eastern egress door, this door is very difficult to close, presenting security and accessibility problems.

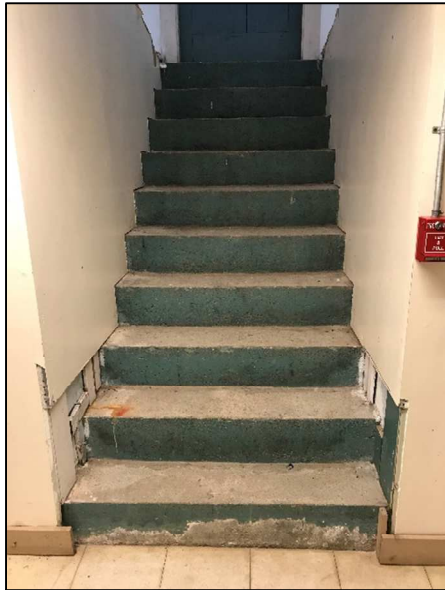
Figure III-29: Base of western egress

modern life-safety code. The concrete steps have unfinished concrete treads and painted concrete risers which are also $\frac{1}{4}$ " taller than current code allows. There are visible areas of water damage on the face of most of the risers, most notably the one at the bottom which is in direct connection with the lower level floor, and there are stains on several of the tread surfaces (Figure III-29). The gypsum

board walls of the Community Room wrap the corner of this opening; however, the base of the wall for the first two steps is not finished with furring and concrete wall exposed (Figure III-29). The top of this gypsum board has been left exposed and unfinished, and now has extensive damage. Portions of the top of the concrete foundation wall for this egress volume have been left exposed, reducing the thermal performance of this space. Additionally, this stem wall has a worn edge at the exterior of the door threshold (Figure III-31). The paint in this egress stairwell is in good condition; however, there are areas of chipping and staining. The door has six panels, two of which are glazed and allow natural light to filter into the stairwell and has areas of paint chipping and

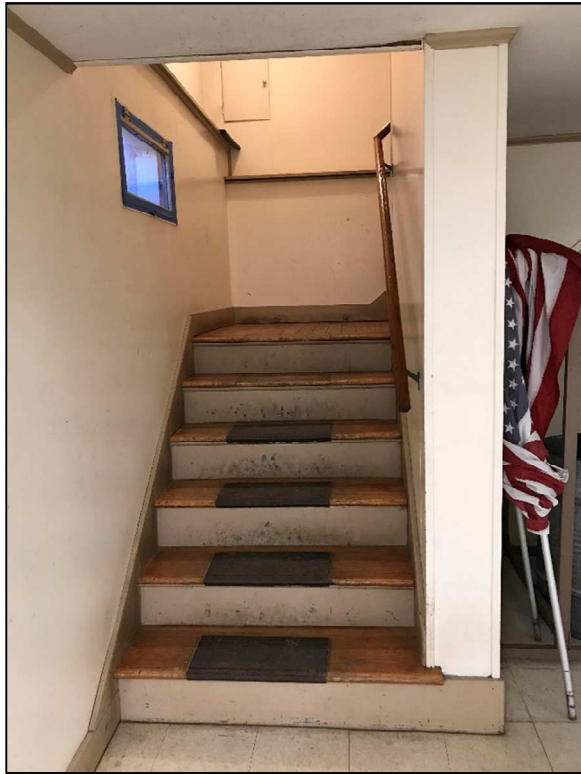
Figure III-32: Connecting stair to main level

Connecting this level with the main level is a wooden staircase located in the southeastern corner of the building (Figure III-32). The stair is in good condition, with wooden treads that have areas of wearing from use. Centered on each step is a grooved rubber tread. These are in fair condition; however, they do not provide full coverage for the step, exhibit much wear and aging, and several are missing. Each painted riser has scuff-marks and some scrapes. A simple wooden rail has been installed on the interior walls of the stair and is in good condition. The wooden baseboard installed at the base of the walls throughout the Community Room, continue up through the stair, and are in good condition (Figure III-33). Two light fixtures provide adequate levels of lighting within the stairwell; however, they are not energy efficient. The stairs are enclosed as they enter onto the main level, and a six-paneled wooden door is located at the top of the stairs, opening into the Foyer.

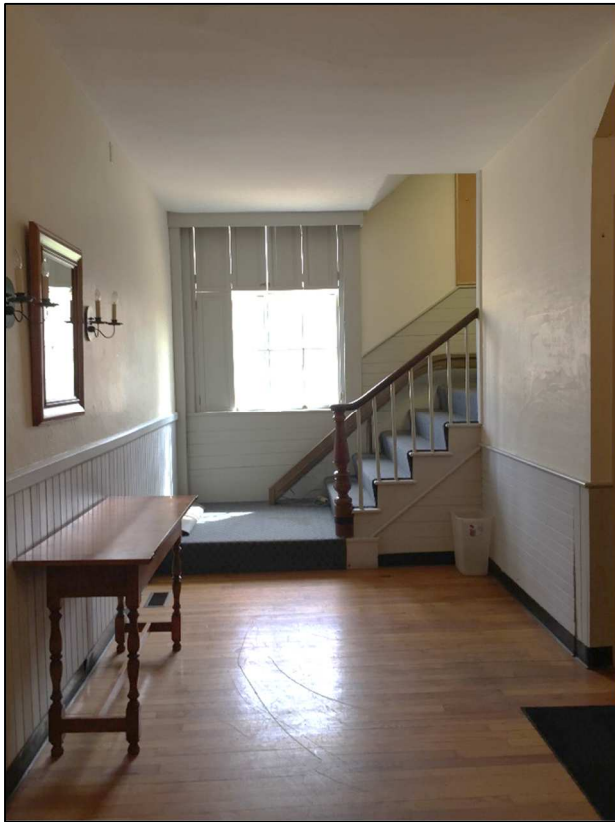
Figure III-34: Looking east within the Foyer

The Foyer is generally in good condition; the wainscoting on the north, west and south walls has a wide chair rail, vertically oriented beadboard and a modern vinyl baseboard (Figures III-34 & 35). On the eastern and southern walls of the enclosed

(Figure III-34). This chair lift is in poor condition; it does not function properly and is a visual and physical obstruction within the stairwell. The wooden handrail on the inside wall of the staircase is in good condition. The staircase is inadequately illuminated with minimal fixtures. There is a six-panel wooden door at the top of the stairs that descend from

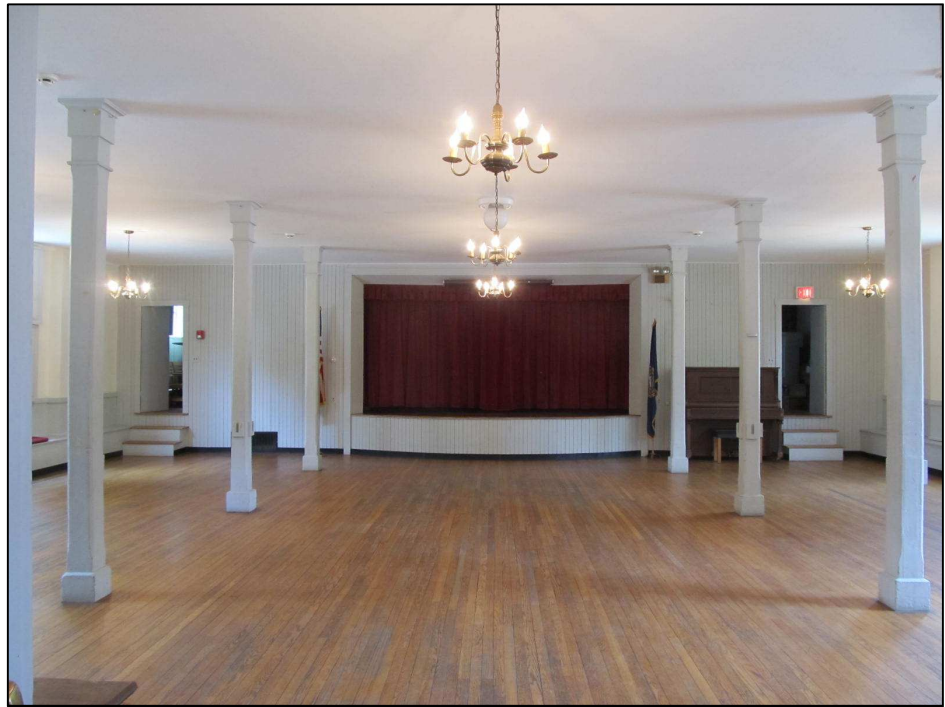
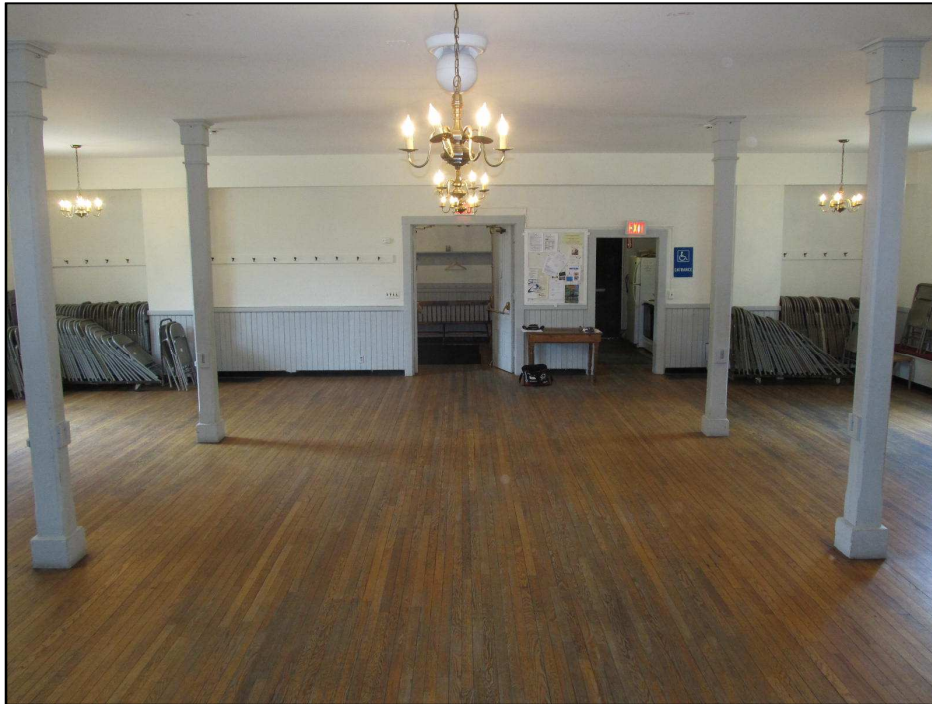
Figure III-37: Southern wall of the Meeting House

Figure III-38: Northern wall of the Meeting House

light to the space. In general, these windows are in good condition, each with an exterior storm window that is under-performing in energy efficiency, as noticeable drafts are present. The northeastern window within the space has some minor damage and has a clear plastic covering installed on the interior. Each window has an interior set of bi-folding shutters (Figure III-40). Each shutter functions properly; however, there are areas that scrape against the plaster ceiling. The ceiling is in good condition with minor areas in need of repainting due to the shutters. Nine chandeliers provide lighting to the entire Hall and are centered within each of the structural bays (Figures III-37 & 38), and appear to be in good condition. The six structural wooden columns are in good condition; however, the faces of the posts showcase damage from use of the space, and modern wooden 'saddles' have been installed on each column, providing the ability to set-up the voting stalls (Figures III-37 & 38). Boxed framing posts which are visible along the east and west walls (three on each wall) have been integrated into the built-in benches. The heavy timber posts are plastered over and are in good condition. In general, the paint within this space could use refreshing, and should be evaluated for historic accuracy. The entire space is finished with a thin-board wooden floor with a light, natural stain that is in fair condition due to large areas of wear and use. Due to a combination of

previous refinishing and high traffic, the boards have become so thin that they need to be replaced and cannot be refinished any further (Figures III-37 & 38).

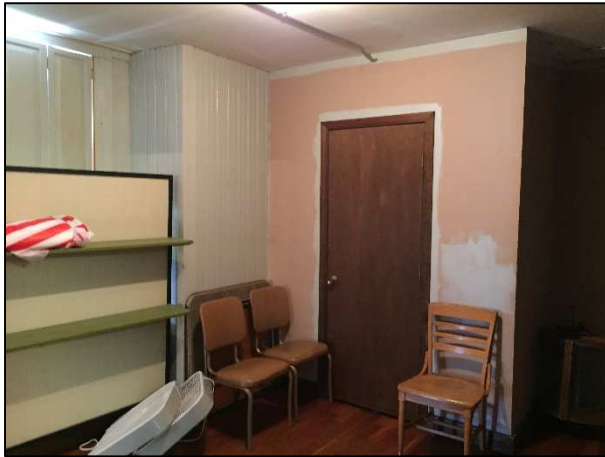
Figure III-44: Western side of backstage with storage

Figure III-47: Northern storage room, typical door
room (107) is located within the northwestern corner of the building along with a beadboard enclosed mechanical duct (Figure III-44). This storage closet has no artificial lighting and has a modern, hollow panel door.

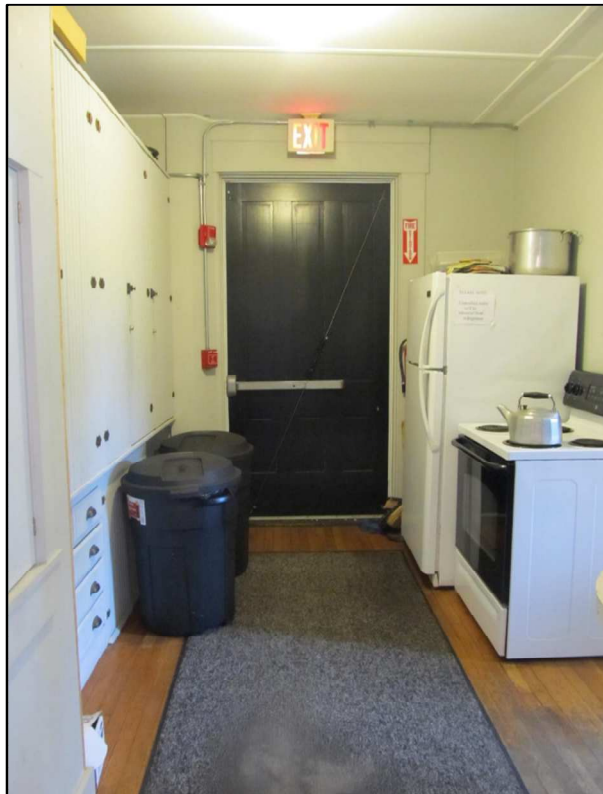
Figure III-48: Accessible entry through kitchenette

The door off of the southwest corner of the Meeting Hall leads into the Kitchenette (102). The floor of this area is worn and damaged from foot traffic between the hall and exterior door. Built-in cabinets and the dumbwaiter have been installed along the entire eastern wall and are in fair condition (Figure III-48). The handicap accessible entrance into the building is located along the southern wall and is the second of the two main doors on the building's southern façade. This six-paneled wooden door has modern hardware on it and is generally in good

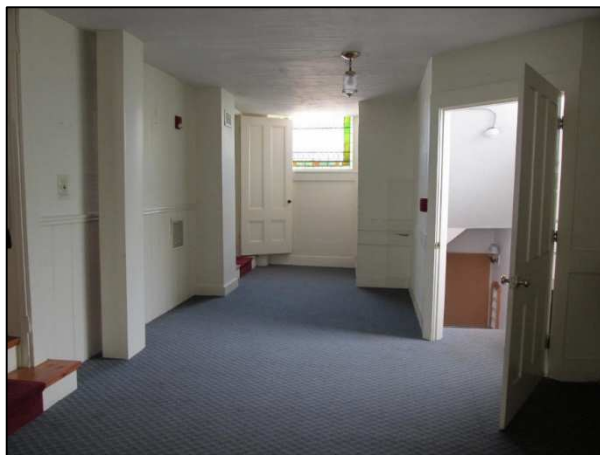
Figure III-50: Narthex looking east

The plaster walls and wainscoting of the Narthex and Pastor's Office are in good condition with minimal cosmetic cracks to the plaster (Figures III-50 & 52). A wide chair rail wraps from the central portion of the southern wall of the Narthex to the door enclosing the staircase leading to the Choir Loft (301) in the southeastern corner. This mid-nineteenth century door is in fair condition, with large areas of scratches and paint peeling. The door has a mixture of historic door hardware with a modern automatic door closer, making the door difficult to operate. The north wall of the Narthex has a wide opening centered on the overall structure of the building, providing access into the Sanctuary (Figure III-53). Two stained wooden steps with a central carpet runner lead from the Narthex floor to the Sanctuary floor and are in good condition. Grab bars have been installed at either side of the opening to assist with the stair transition, and old hinges are still located within the opening's casing. A single four-panel wooden door is located at the northeast corner of the Narthex and provides an additional access point into the Sanctuary (Figure III-50). The ca. 1867

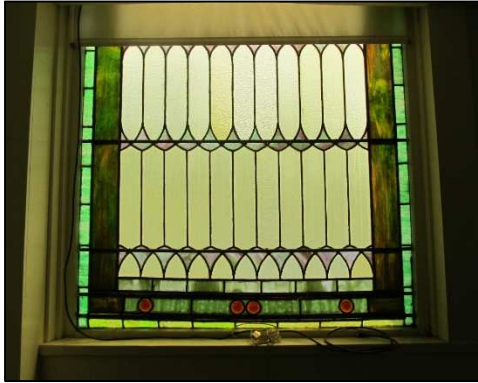
Figure III-51: Typical stained-glass window

the other within the pastor's office. Both southern windows are in poor condition, with significant deflection at the bottom of the sash, cracked or broken glass, cracks within the perimeter leading, and a majority of the tie wires have pulled away, rendering the horizontal support bars useless (Figure III-51).² Two additional stained-glass windows are located within the 1867 addition (southern bay): one on the east wall within the Narthex and one on the west wall within the Pastor's Office. These additional windows are in fair, structurally sound condition, with minor areas of deflection, cracked or broken glass, cracks within the perimeter leading, and a majority of the tie wires have pulled away, rendering the horizontal support bars useless. All four of these windows are bisected by the floor of the Choir Loft above, leaving the lower portion of the glass visible at this level, and the upper

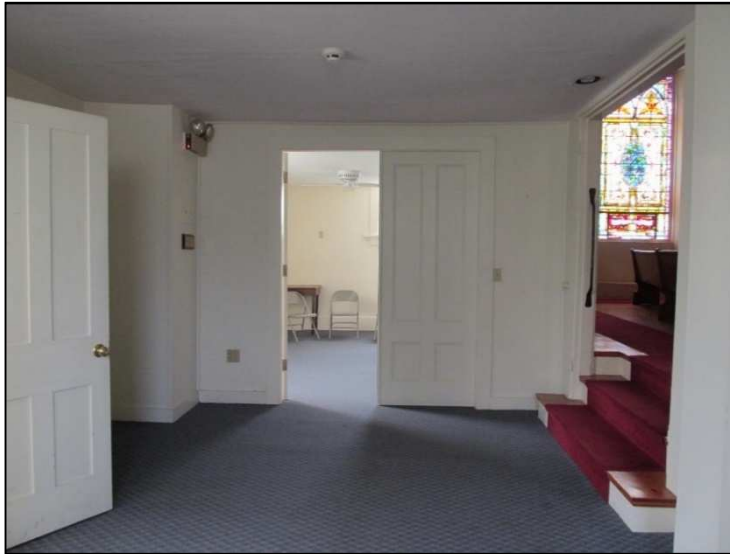
Figure III-52: Narthex looking west to Pastor's Office

The Pastor's Office, located to the west of the Narthex, is accessed through a set of four-paneled wooden double-doors that are in good condition (Figure III-52). There is no threshold between the two spaces. There is a four-panel wooden door in the northwest corner of this space, providing an access point into the Sanctuary (Figure III-55). This door matches that in the northeast corner of the Narthex with the exception that the central carpet runner does not match the carpet within the Sanctuary. Along this northern wall, there are two rectangular plaster enclosures within the vertical plane of the wall with a built-in bookcase constructed between them. The eastern enclosure contains the northwest post of the Bell Tower. The

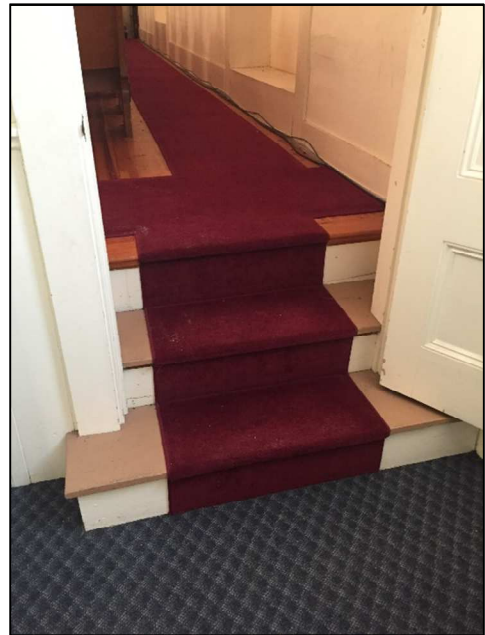
Figure III-54: Steps leading to Sanctuary

door is in good condition with minor areas of paint cracking or peeling and contemporary nineteenth century hardware. As with the primary entrance to the Sanctuary, two painted wooden steps with a central carpet runner, lead up to this doorway (Figure III-54). Along this northern wall, there are two rectangular plaster enclosures, protruding from the vertical plane of the wall; the eastern volume

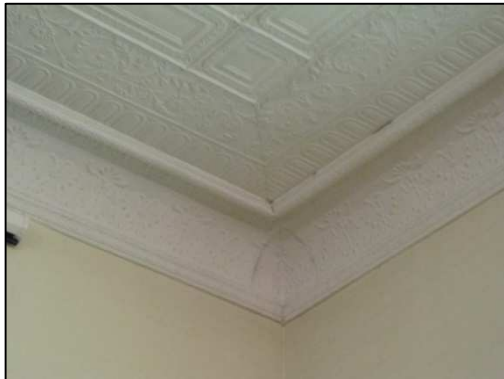
Figure III-56: Metal ceiling & crown molding

The Sanctuary (203) has a painted, stamped metal ceiling, nearly twice the height of the Meeting Hall below. The metal ceiling and matching crown molding are in good condition, despite having a fair amount of dust on its surface, and a few areas of water damage and rust (Figure III-56). Four chandeliers and four ceiling fans have been installed within the ceiling, as well as a central globe fixture that is part of the space's A/V equipment. The fixtures are in good condition and provide adequate lighting to the space, with minimal dark spots (Figure III-57). A red carpet is installed along the aisles of the room and atop the entire altar platform. This carpet is in fair condition with some soiled and worn out areas. Twenty-two wooden pews are organized in rows within the space, generating narrow aisles along the exterior walls and a large central aisle running north to south, leading to the altar (Figure III-58). The pews are in good condition; however, because they were added at a later date, they do not match in wood type or finish, the other wooden elements at the Altar.

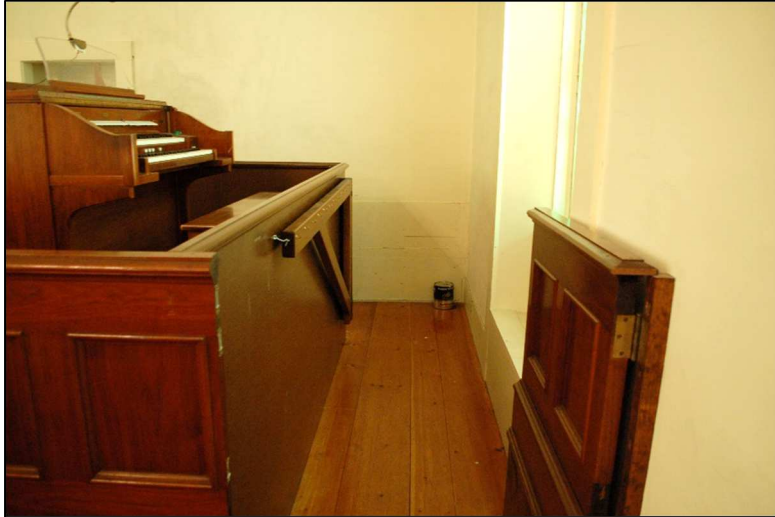
Figure III-61: Dark wood wall panels with integrated egress path

wall. An access path has been created that follows the northeastern exterior wall to a secondary egress door on the north wall, through a dark wood paneled door integrated with the low wall of the Organ (Figure III-61). These low walls are in good condition as are the altar and two lecterns. A rectangular enclosure with integrated screening in the northwestern corner of the Altar encases mechanical

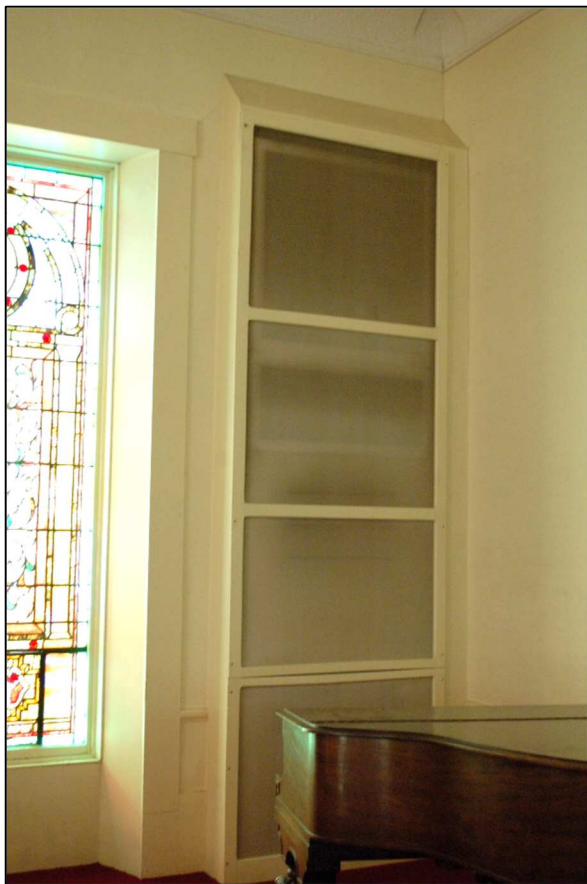
Figure III-62: Mechanical ductwork enclosure

ductwork (Figure III-62). Two carpeted steps provide access from the Altar to the secondary egress door at the north of the platform. The egress door is recessed within a thickened wall, has simple stock trim boards and an unfinished threshold of wood flooring (Figure III-63). Crossing these steps and causing a potential trip hazard is a cluster of A/V wires and cords. Similarly, there is a set of A/V wires and cords that run the length of the eastern wall at its base. This northeastern corner showcases the worst condition of the plaster walls within the space; the entire section is covered with grime and has large cracks in the plaster (Figure III-59). The remainder of the plaster walls within the space showcase less dirt and have few cosmetic cracks; however, minor repairs, cleaning and repainting are needed.

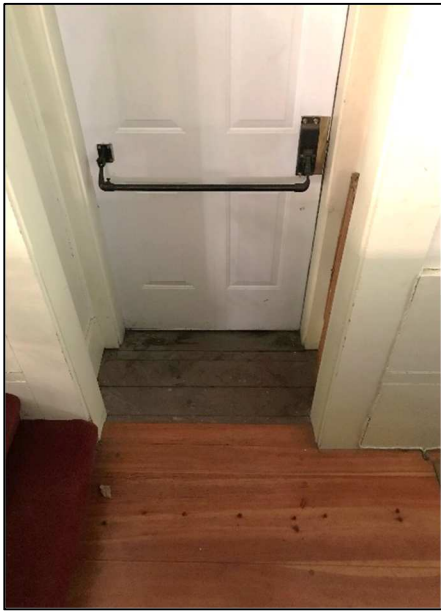
Figure III-63: Northern egress door

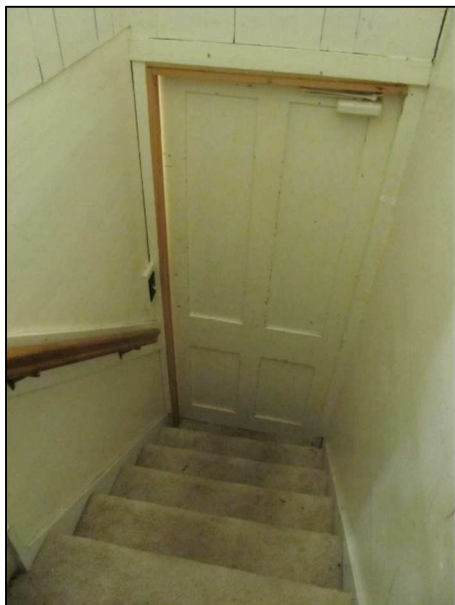
Figure III-65: Stairway to Choir Loft

A set of steep, carpeted stairs from the upper level is the only means of access to the space (Figure III-65). This stair, wrapping the southeastern corner, has mixed vertical board and plaster walls along its inside corner with a wooden handrail installed on a flat stock trim board, that are in fair condition with minor damage, peeling paint and cosmetic cracks. A beaded chair rail bisects the vertical boards on the stair side, with boards above and below not aligning with each other. The vertical boards become a partial-height wall capped with a curved rail with bookshelves installed against it within the Choir Loft (Figure III-66). The carpet on the

Loft Stairwell – The existing stairwell leading to the *Loft* is to be moderately reconfigured to provide a more compliant and accessible stair and to enhance the stained-glass window preservation efforts. Existing treads and risers are to be further evaluated for structural integrity, repaired where necessary and refinished. New treads and risers are to be wood, finished to match, with a central non-slip tread installed at each step, and a wooden, wall-mounted handrail should run the interior perimeter of the stair. To the extent practicable, salvage and reuse material still of good quality. The vertical board, partial-height railing wall is to be salvaged and reinstalled, and where new railing is required, install new partial-height railing walls that match material, profile, dimension and finish. Walls and railings are to be finished to match the existing, and the existing walls are to be cleaned, repaired where necessary and refinished.

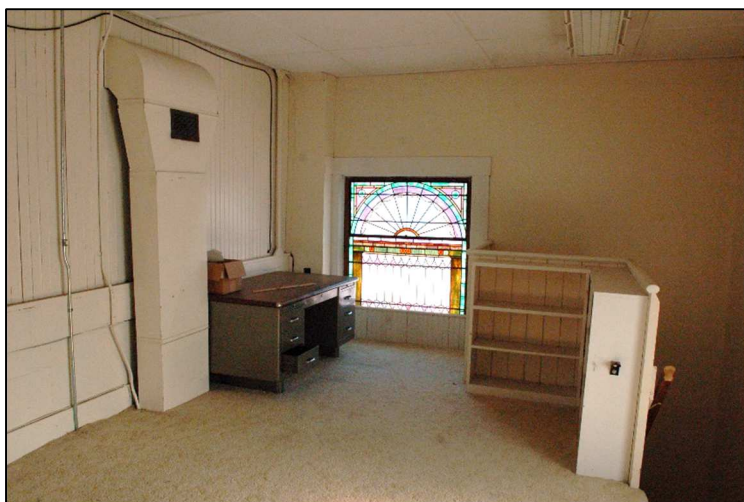
Figure III-66: Choir Loft looking east

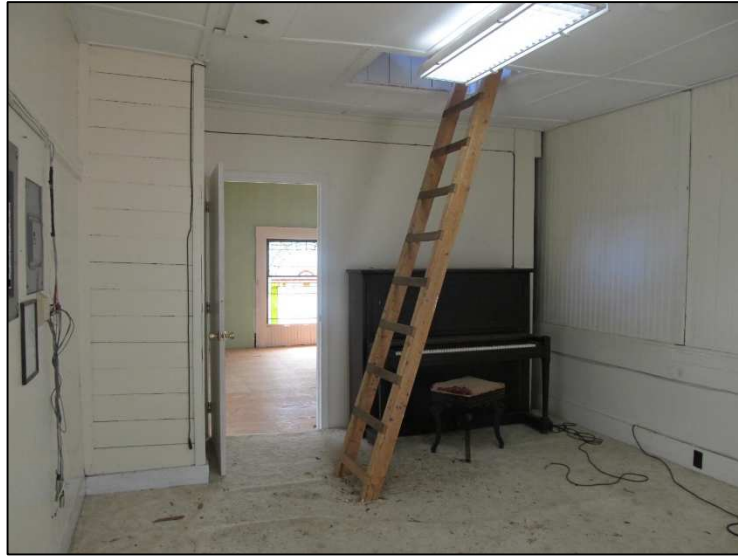
stairs continues throughout the Choir Loft and is in poor condition with stains, vermin and fowl waste everywhere, and areas where the carpet has come loose, creating ripples, and causing tripping hazards (Figure III-67). The walls within the Choir Loft are a mix of materials and casings with wires installed across the surfaces, cosmetic cracks in the plaster sections, and mixed paint finishes. A modern dividing wall separating the

Choir Loft and the Loft Office is finished with gypsum board on its eastern side, but has remained unfinished on its western face, with exposed studs (Figures III-67 & 69). A modern, hollow panel door has been installed within this wall and is in fair condition. The walls within the Loft Office have large cracks, plaster failure along the base, and grime covering the entire surface (Figures III-69 & 70). No baseboard exists within the space along the south and west walls, leaving the studs of the exterior wall exposed with no insulation. The Loft Office has an unfinished plywood floor through the whole space, with a few soft spots towards the southwestern corner, making the floor unsafe and unusable.

Figure III-67: Choir Loft looking west at Attic access & Office

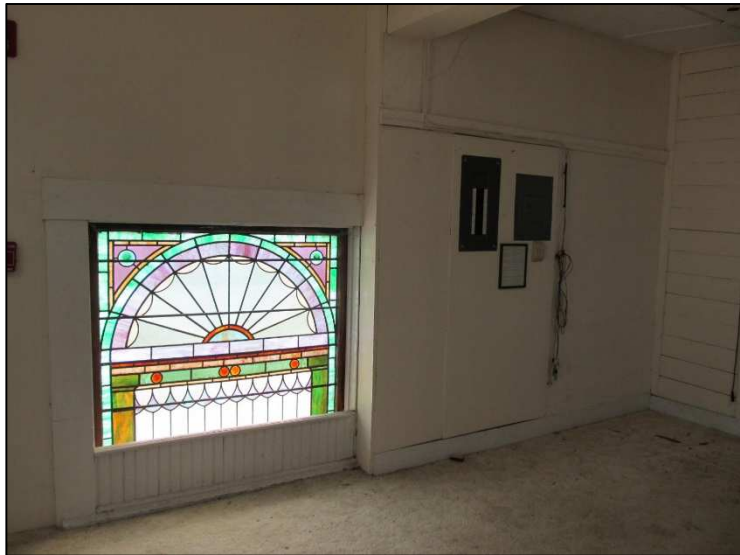
Figure III-68: Choir Loft looking southwest

The upper portions of the four stained-glass windows of the Narthex and Pastor's Office extend into the loft. The flat stock trim of each window is in good condition, with minor cosmetic imperfections. Installed within each window opening is an eighteen-inch tall, vertically oriented beadboard partition with a curved cap (Figure III-68). This partition has been installed at the floor and provides protection to each window

Window Wells – In order to provide increased safety around the stained-glass windows and protect the sash from internal damage it is recommended that window-wells be created between the narthex and *Loft*. In order to achieve this, an approximately 5-foot by 2-foot area of the flooring directly adjacent to each of the four stained-glass windows will need to be removed. The low beadboard rails at each of the windows should also be removed, as the height of these railings creates a safety hazard and do not comply with *Building and Life Safety Code*; the existing rails only protect the window at the floor level and do not prevent an individual from falling out the window. New railings should be installed at each opening providing the required safety barrier as well as achieving an aesthetic that corresponds with the historic fabric of the space. These openings are necessary to allow the complete and unobstructed stained-glass windows to be viewed from the exterior; today they are divided by the visible structure and insulation of the floor abutting the window. These new window wells can remain open with a Code-compliant railing partition installed at the perimeter of each well, which will also increase the level of safety within the *Loft*.

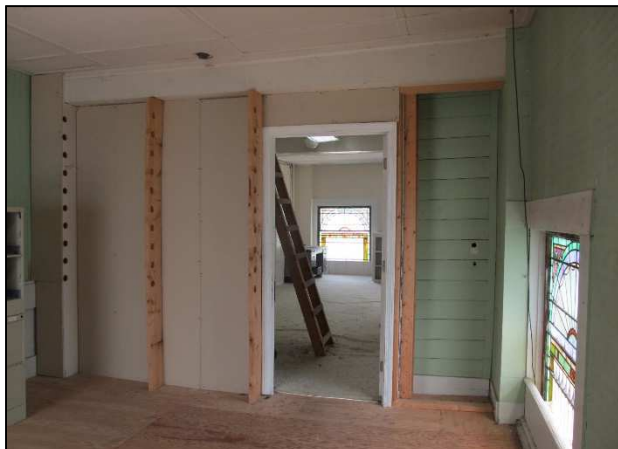
Figure III-69: Loft Office looking east

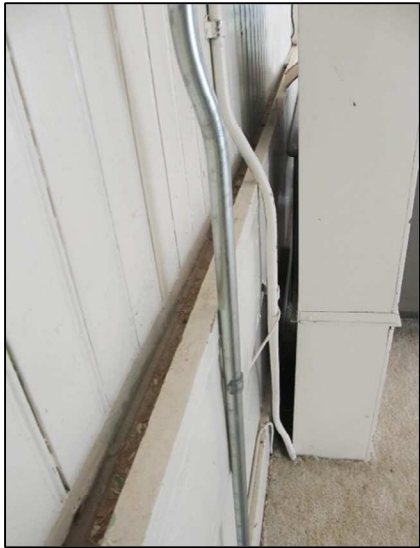
Figure III-71: Wiring at sliding panels

across this wall, running both horizontally along the wooden baseboard and vertically up the face of the wall (Figure III-71). In addition, two mechanical ducts are located at this level, continuing up from the upper level; one to the east and one to the west, both puncturing through the upper portion of the northern wall (Figures III-66 & 70). Approximately two-foot six-inches above the floor, a horizontal trim band runs the entire length of the wall, above which the wall is all vertically oriented beadboard (Figure III-73). This trim band becomes the sill of the arched opening between the Sanctuary and the Choir Loft and is in fair condition with several areas of splintering wood. From the Sanctuary, the arched opening can be seen clearly with thin trim running its perimeter and beadboard wrapping the arched opening (Figure III-60). The beadboard wall splits at the

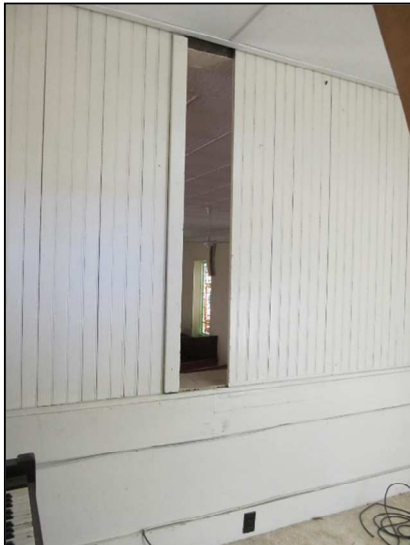
Figure III-73: Beadboard sliding panels, opening to Sanctuary

center and can be pushed open to either side, through an integrated wooden track within the wooden trim (Figure III-73). The track is in fair condition, although the doors do not slide smoothly and there is no hardware or handhold to assist in opening them (Figure III-72). The installation of the mechanical ductwork and electrical conduit in the path of the sliding beadboard doors prevents them from being fully opened (Figure III-71). Additionally, the beadboard itself is in varying condition with areas of extensive paint peeling, cracking and damage from attaching elements and equipment to it. Directly in front of the beadboard partitions are the two encased structural columns carrying the load of the Bell Tower above. These are wrapped in gypsum board with north-south running horizontal beams connected at the ceiling

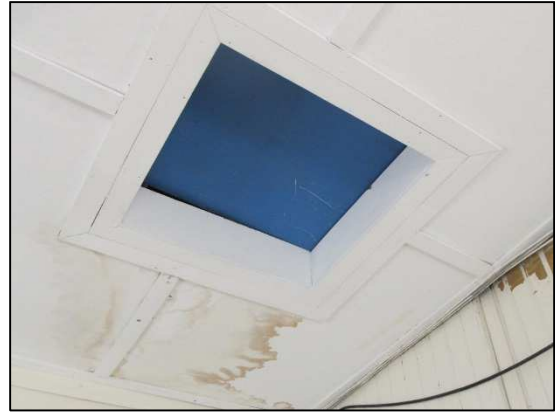
Generally, the ceiling of the loft is in good condition, with several minor areas of water staining (Figure III-74). Modern, flat stock trim has been installed across the ceiling's surface, creating a simple gridded pattern. At the junction of the ceiling and the northern wall within the Loft Office, a gap is located, exposing the flat ceiling above which appears to have nineteenth century decorative painting patterns (Figure III-75). In the eastern bay of the Choir Loft, an opening in the ceiling is still visible, although it is inaccessible and has been sealed off (Figure III-74). The opening has been cased in flat stock wooden trim and the horizontal access panel remains recessed within the opening, and is painted blue, contrasting the white ceiling. Located within the central bay of the Choir Loft is a second access hatch that provides access to the Attic and Bell Tower (Figure III-76). The Attic hatch is reached by climbing an unsteady wooden ladder, in poor condition. The opening is cased in flat stock trim with vertical board running within the opening to the recessed access hatch. The trim and vertical boards have areas of paint scratches and grime from regular use. The hatch door itself has no hardware except for hinges, and is in fair condition with dings, scratches and grime located on its painted underside and its topside unfinished. Minimal light fixtures are located within this space, none of which provide adequate levels of illumination.

Figure III-74: Unused access hatch to Attic

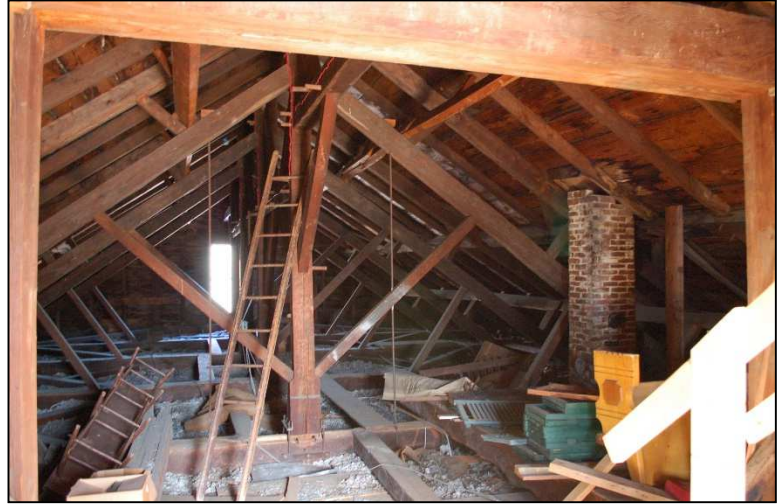
The attic level of the Greenfield Meetinghouse is in fair condition (Figure III-77). The single access point into the Attic is via the hatch in the ceiling of the Choir Loft at the southern end of the building. Within the central zone of the Attic, a simple floor has been constructed upon which staircases and ladders are installed providing access to the Clock Room and Bell Tower above. The entire

Figure III-77: Greenfield Meetinghouse attic, facing northeast

volume is open, and the structure of the roof is fully exposed. There is no floor in the attic of the meeting house itself, the floor is only constructed in the tower portion of the space. Travel above the Sanctuary is limited to heavy timbers, making access to the remainder of the space difficult and hazardous.

The roof of the meetinghouse is supported by east-west spanning timber trusses that support rough-cut purlins spanning north-south. The purlins support rough-cut common rafters which support board roof sheathing. The timber trusses are in good condition. There is a noticeable change in structure within the southern section of the Attic from when the tower was added and then enclosed. Between the trusses and the joists, cellulose insulation has been placed. Extra pews, books, shutters and other miscellaneous items are stored throughout the attic, balanced between joists in attempts to not puncture the ceiling below. An old chimney structure is located within the southeastern side of the Attic. This chimney neither

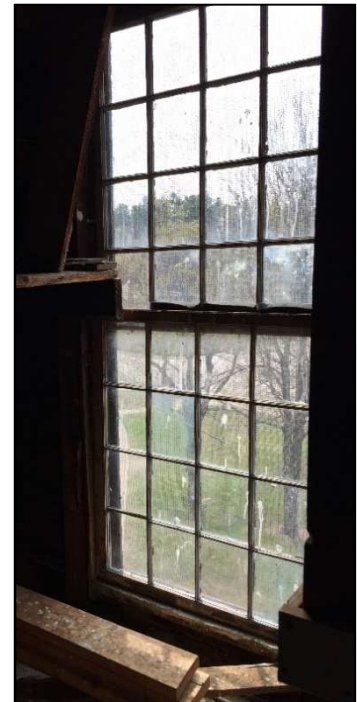
Figure III-78: Attic window

penetrates the roof of the building, nor the ceiling of the Sanctuary, and has no functional use with the building's mechanical system. It is in poor condition with mortar degradation and bricks slightly shifted. Smoke detectors have been installed throughout the volume; however, there are no light fixtures, making the north and south double-hung windows the only source of light. Both windows are in fair condition;

however, neither have hardware any longer nor can they be operated, as they have been sealed shut (Figure III-78). The northern window has a broken pane of glass which allows for water infiltration and animal access to the space.
