Historic Building Assessment for the Greenfield Meetinghouse

776 Forest Road, Greenfield, New Hampshire

Conducted for the Town of Greenfield

Mae H. Williams, Preservation Consultant & Misiaszek Turpin pllc

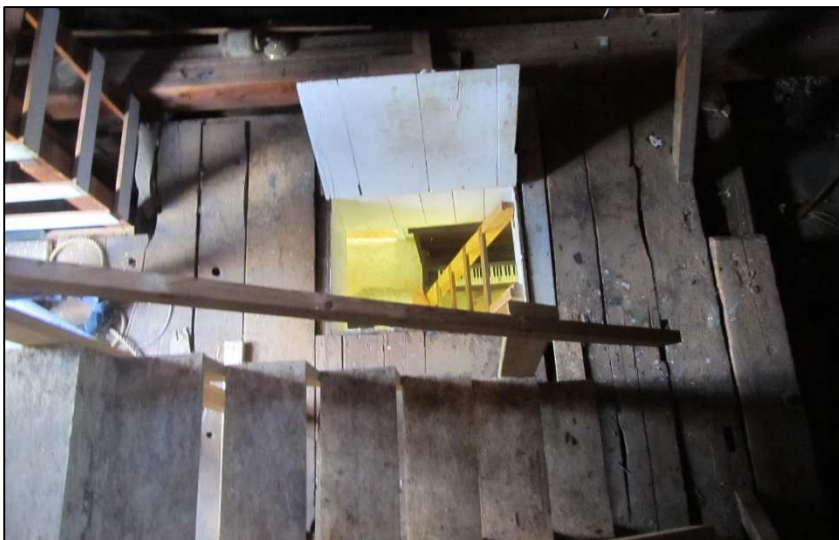
The floor of the tower section is comprised of wooden planks in poor condition, with major soft spots, sagging and broken boards. Integrated into the floor is the hatch door that provides access into the space from the loft level (Figure III-79). There are no railings installed at the perimeter of the floor space, which is a major safety hazard as the floor joists and ceiling below are exposed and would not support any weight on them. Modern stairs have been constructed that provide access to the Clock Room; these stairs have railings and are well constructed (Figure III-80). A platform extends from the landing of the stairs, south and connects with the southern wall of the building. Atop this landing, a ladder is located that provides access to the Bell Tower. Both the landing and the ladder are in fair condition but are in need of some improvements. Centered below the Clock Room above, and hanging into this space, an enclosure of horizontal boards has been created that houses the clock's pendulum, protecting it from any potential hazards. There are two partial enclosures located along the southern wall that encase the clock's counter-weight system (Figure III-81).

Figure III-79: Attic floor

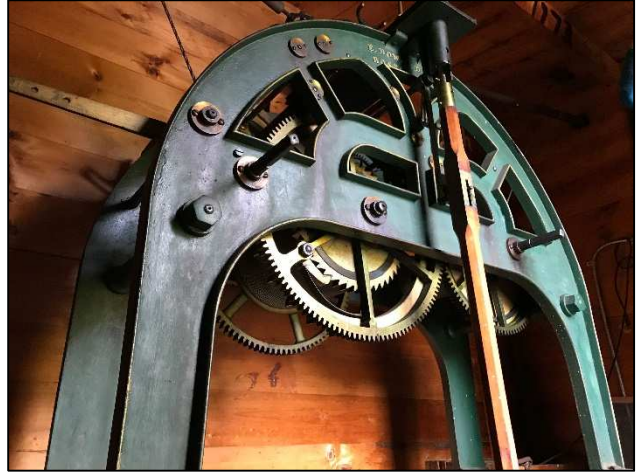
The Clock Room is generally in good condition (Figure III-82). This space is accessed through a hatch in the floor and is centered within the Bell Tower itself (Figure III-83). The room contains the mechanical system of the clock, which is in good working condition. A modern set of stairs constructed within the Attic lead to this hatch; however, due to space constraints, a partial vertical ladder had to be constructed towards the top of the stairs to provide full access into the Clock Room. The plank wood flooring is in good condition with minor use marks and scratches. The thin horizontal board walls are in good condition and have a door integrated on the north wall of the room that opens and provides access to and light from the north-facing double-hung window (Figure III-84). This window is in fair condition for its age; however, it has no hardware. Along the walls are areas of graffiti done over the years marking significant dates, times of construction and people. There is a single lightbulb illuminating the space.

Figure III-82: Clock mechanicals

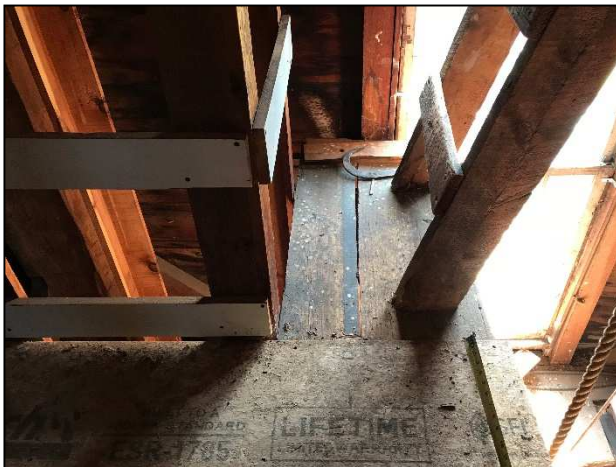
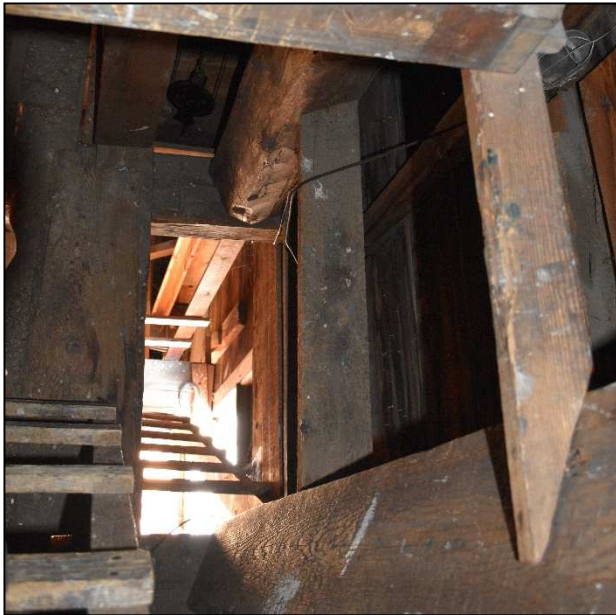
Figure III-86: Access to Bell Tower

Figure III-87: Stairs leading to Belfry

no supports (Figure III-86 & 87). Both ladders are in fair condition, but are in need of improvements, providing increased safety and accessibility for maintenance. The northern window also provides natural light into this space; however, the space remains very dark and difficult to see, as there is no artificial lighting. Large timber columns and beams are visible within this volume and provide structure for the Belfry above. A small, triangular landing has been installed at the top of the second ladder, from which the ceiling hatch to the Belfry is accessible (Figure III-88).

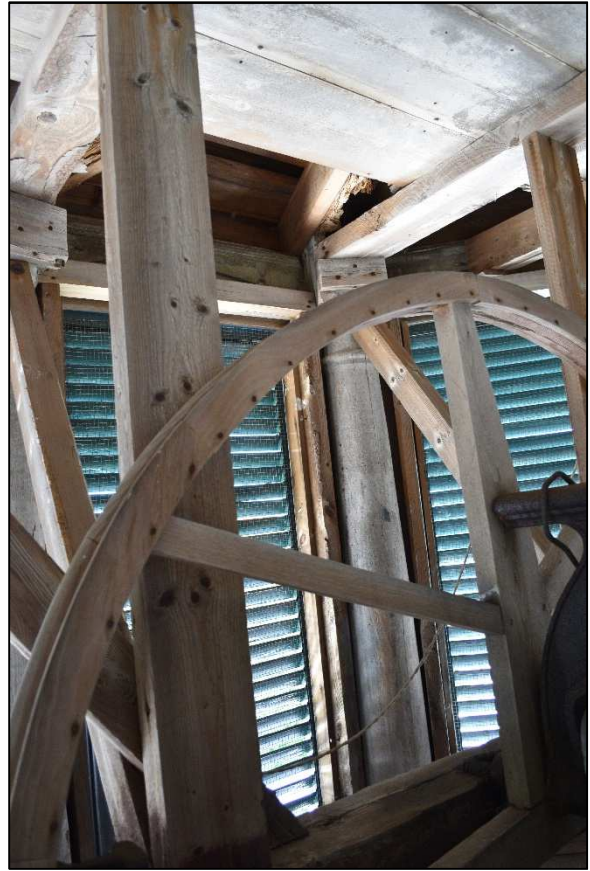
Within the ceiling of the Belfry is a small access hatch that provides access into the Lantern. Though the lantern is in cosmetically good condition from the building exterior, it is in structurally poor condition. From the belfry platform severe insect and water damage to the structure of the Lantern is visible, with entire sections of beams rotted away (Figure III-89). Modern materials were sistered onto the historic beams in the 1980s to give additional structural support. However, the modern dimensional lumber is inadequate to properly support the structure, and the use of modern materials and method in which the modern structure was inserted in a way that detracts from the historic fabric and design.

Figure III-89: Rotted beams at Lantern

Bell Tower – The structure of the octagonal portion of the Bell Tower; the belfry and the lantern, is to be fully reconstructed. All exterior finish and trim materials are to be removed and salvaged to the extent practicable, and reinstalled upon the completion of the tower's reconstruction. The existing louvered panels within each bay of the belfry are to be further evaluated upon removal, repaired in-kind where necessary and are to be repainted. The railings and corner posts are to be further evaluated upon removal, repaired where necessary and are to be repainted. At locations where existing wood finish material cannot be salvaged and restored, new wooden material is to be installed to match the existing dimensions and profiles. The reconstructed tower is to have a copper domed roof that matches the profile, dimensions, and material of the existing roof and the existing, intricate cast-iron weathervane is to be repaired and cleaned where necessary and reinstalled on the tower. At the interior of the Bell Tower, full reconstruction of the ladders and platforms leading from the *Attic* into the *Bell Tower* will provide greater safety and accessibility to these levels. New ladders should be constructed in such a way as to be removable, must be constructed within the confines of the existing Tower's fabric, and make no negative impact on the structure or any existing materials. Install handrails and grab bars where applicable to improve the safety and the access to this area. New hardware should be installed at the access hatch to the *Belfry*. Install new energy-efficient light fixtures throughout the space to provide increased lighting levels for use of the space. Additionally, install smoke detection and notification equipment throughout the space.
