# **Historic Building Assessment for the Greenfield Meetinghouse**

**776 Forest Road, Greenfield, New Hampshire**

Mae H. Williams, Preservation Consultant & Misiaszek Turpin pllc

February 2019

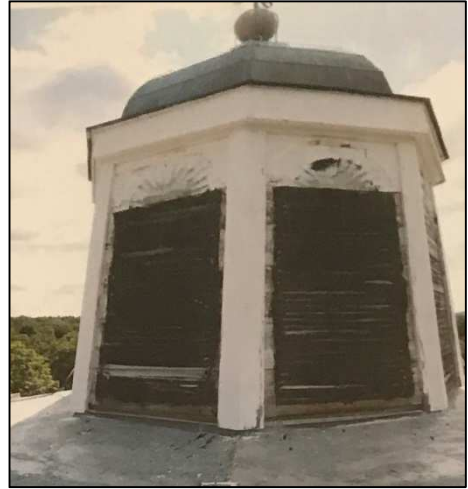
*Figure I-15: The lantern prior to the 2013 repairs.*

sheathing beneath the slates, installed new copper weather stripping to the roof joints, and repaired the slate surface. At the same time, many of the exterior elements of the belfry were restored by Brian Gallien of Ironwood Restoration in Marlow, and the exterior of the lantern was rebuilt with new corner boards and restored louvered panels (Figure I-15).

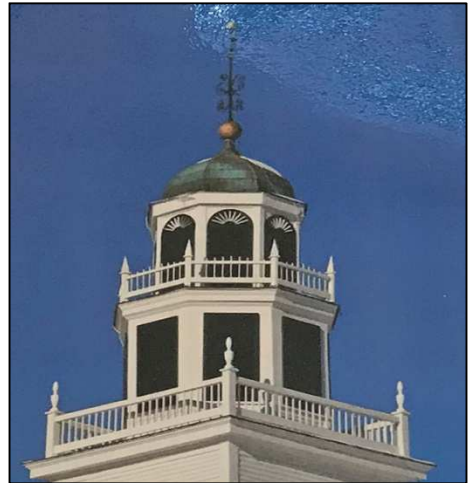
*Figure I-16: The belfry and lantern after the 2013 repairs.*

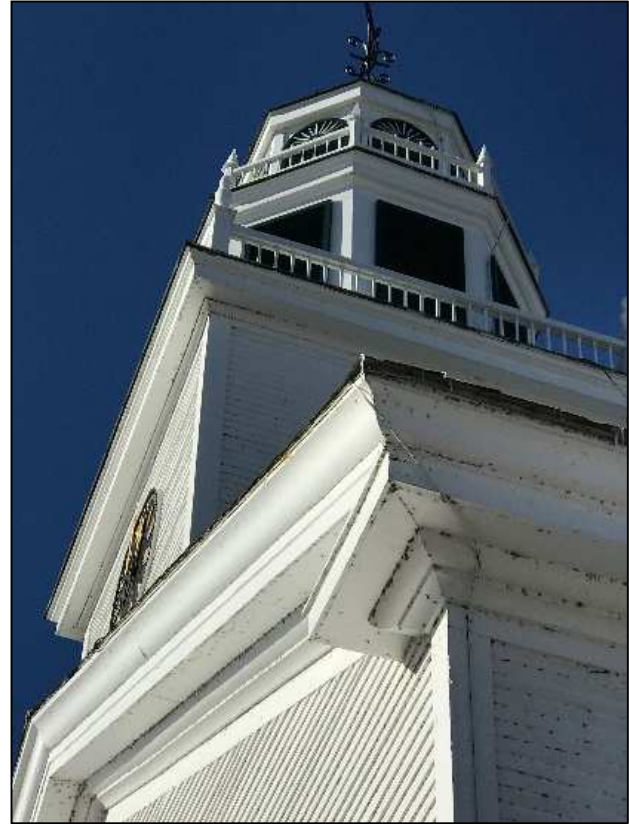
Figure II-7: Detail of roof

The gable roof has a 9" by 12" roof pitch. It is covered in gray slate, set in a plain pattern. The slate was installed in 2013 to replace an earlier historic slate roof that lies over an even older historic wooden shingle roof. There is a shingle molding at the narrow fascia, flat soffit, bed moulding and narrow frieze. The Meetinghouse has a boxed eave with a narrow frieze wide bed molding, narrow fascia and wide shingle molding (Figure II-7). There are shallow cornice returns at the gable ends of the building, and the moldings of the gable-end match that of the eave.

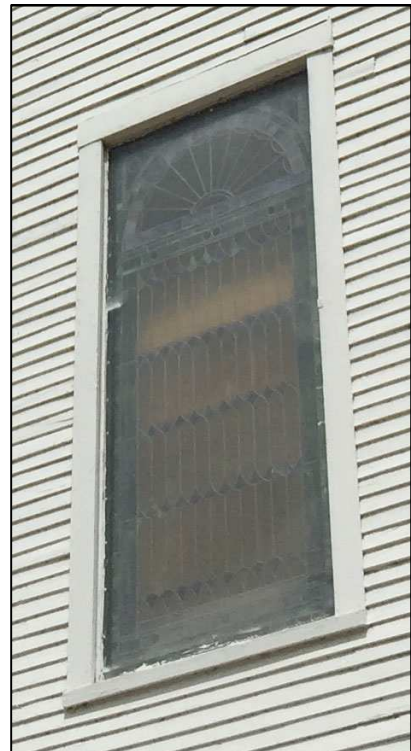
*Figure III-6: Upper level stained glass window with plexiglass covering*

Located directly above each door is a large stained-glass window, installed in 1905, in front of which a plexiglass panel has been installed (Figure III-6). Visible through each window is the modern floor construction of the loft level. The windows themselves are intact, although they are in need of immediate restoration work, repair and protection. The storm windows installed at the exterior of each stained-glass window are in poor condition and appear to be potentially causing damage to the window leading with captured moisture between the surfaces. Flat-stock casing, sill and header surround the stained-glass window, and from visual inspection from ground level, appear to be in fair condition. Centered within the peak of this southern gable face is an historic wooden, 16/16 double-hung window accessed from the attic of the Meetinghouse. A screen is installed on the exterior. The window is in fair condition. Articulated trim and a flat-stock sill surround this window, with a more detailed header corresponding with the headers of the entrance doors. From

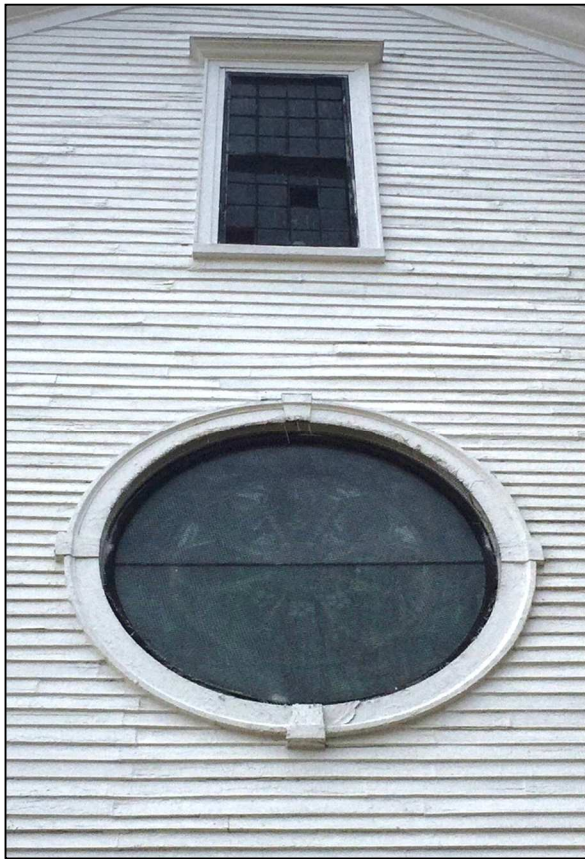
*Figure III-8: Windows at north elevation*

Centered on the north façade and located behind the altar within the sanctuary is a single, circular stained-glass window, installed in 1905 alongside the ten other rectangular stained-glass windows (Figure III-8). The window is intact but in need of immediate restoration work, repair and protection. Circular trim casing surrounds the window with a simple edge molding and four decorative keystones located at each quadrant. From ground-level inspection and photography, this woodwork appears to be in fair condition, with areas of paint peeling and some cracking. Unlike the other stained-glass windows, this unit has no storm window installed on the exterior; rather, a mesh screen has been installed in some fashion that has generated perimeter fraying. Centered within the peak of this northern gable face is an historic wooden, 16/16 double-hung window accessed from the attic of the Meetinghouse. The window is in poor condition, with multiple panes of glazing missing and extensive paint failure. Articulated trim and a flat-stock sill surround this window, with a more detailed header corresponding with the headers of the main entrance doors. From ground-level inspection and photography, these elements appear to be in fair condition.

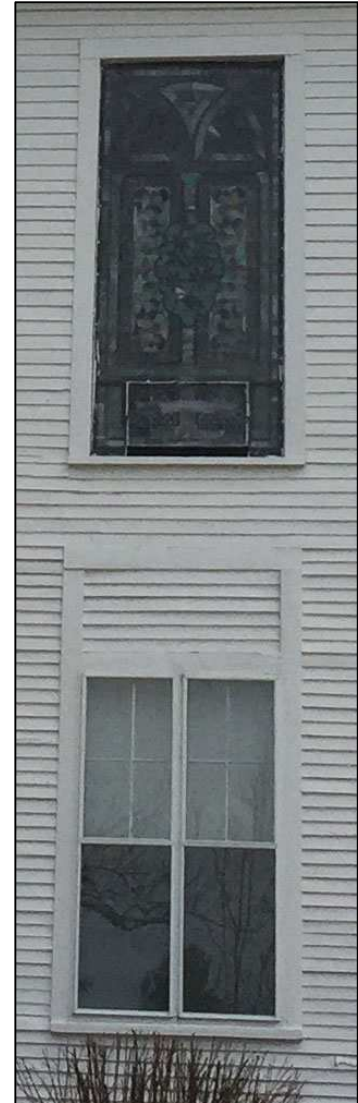
*Figure III-10: Side-elevation windows*

The main level has four large, 8/8 double-hung wood windows (Figure III-10). The ca. 1900 sash are in fair condition, but restoration work and repair are needed to maintain the units. Each is retrofitted with exterior storm windows. These metal storm windows have altered the historic appearance of the windows, despite increasing energy performance of the opening. Flat-stock casing and sill surround each window and are in fair condition. At the top of each window, the trim extends approximately two-feet above the window head and has been infilled with 3-inch exposure horizontal clapboards. This area was added in ca. 1867 to visually mimic the extended height of the windows along the sanctuary above and is purely decorative.

Located directly above each main level window is a large stained-glass window at the upper level (Figure III-10). These windows were installed in 1905 and are protected by plexiglass panels. Visible through the southernmost window is the modern floor construction of the loft level. The windows themselves are intact, although they are in need of immediate restoration work, repair and protection. The storm windows installed at the exterior of each stained-glass window are in poor condition and appear to be potentially causing damage to the window leading with captured moisture between the surfaces. Flat-stock casing, sill and header surround the stained-glass window, and from visual inspection from ground level, appear to be in fair condition.

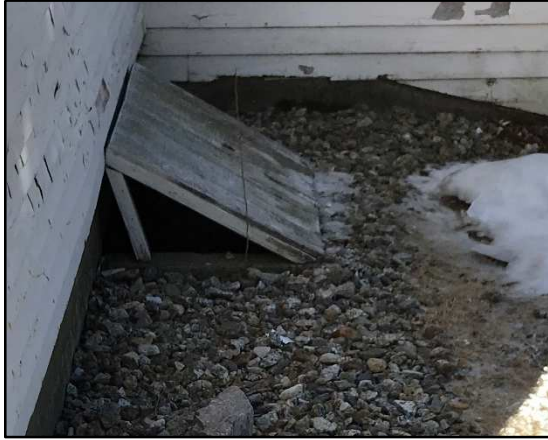
*Figure III-11: Typical window well & cover*

Located along the foundation are two window wells with windows to the lower level (Figure III-11). These concrete wells are covered by temporary covers that are constructed from modern dimensional lumber with a sloped surface of various materials from horizontal clapboards to planks. These elements are in various conditions, with some areas of paint, but are generally in fair condition.

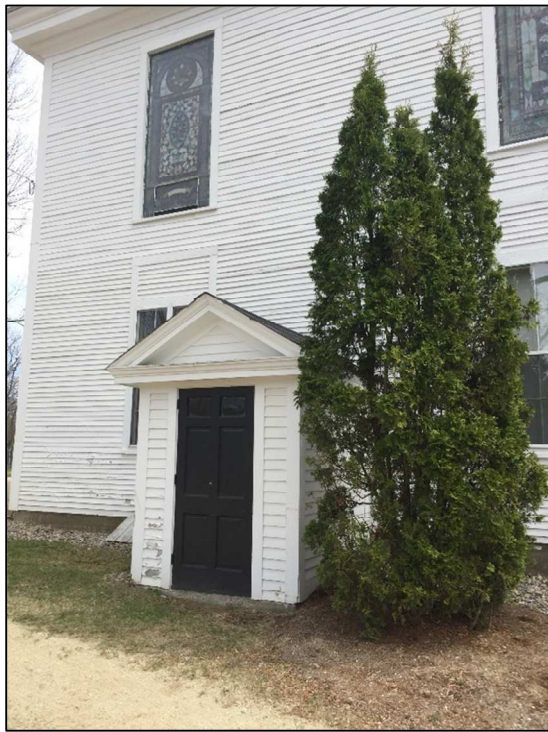
*Figure III-12: Western egress volume*

The western façade of the building is quite similar to the east and defined by its eight large windows and is the location of an emergency egress from the basement, constructed between the northern set of windows. This egress volume is much smaller than its eastern counterpart and has a simple gable roof. A horizontal cornice, supporting wide overhangs, divides the volume and headers the door (Figure III-12). A wooden door with four raised panels and two glazed panels, located on the volume's western face, has no exterior hardware and is in fair condition; however, is difficult to close. Flat-stock trim surrounding the door is in fair condition with paint chipping. The exterior of the concrete foundation, acting as the threshold, has chipping and wear, exposing aggregate, but is otherwise in good condition.

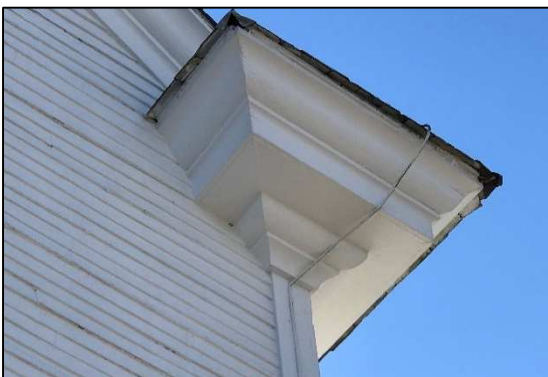
*Figure III-13: Roof fascia & soffit detail*

The gabled roof of the Meetinghouse, which was more recently renovated and re-clad, is covered with slate tiles that are in good condition. The roof is edged with a shingle molding at the narrow fascia, flat soffit, bed molding and narrow frieze that are in fair condition, with areas of peeling paint and grime (Figure III-13).

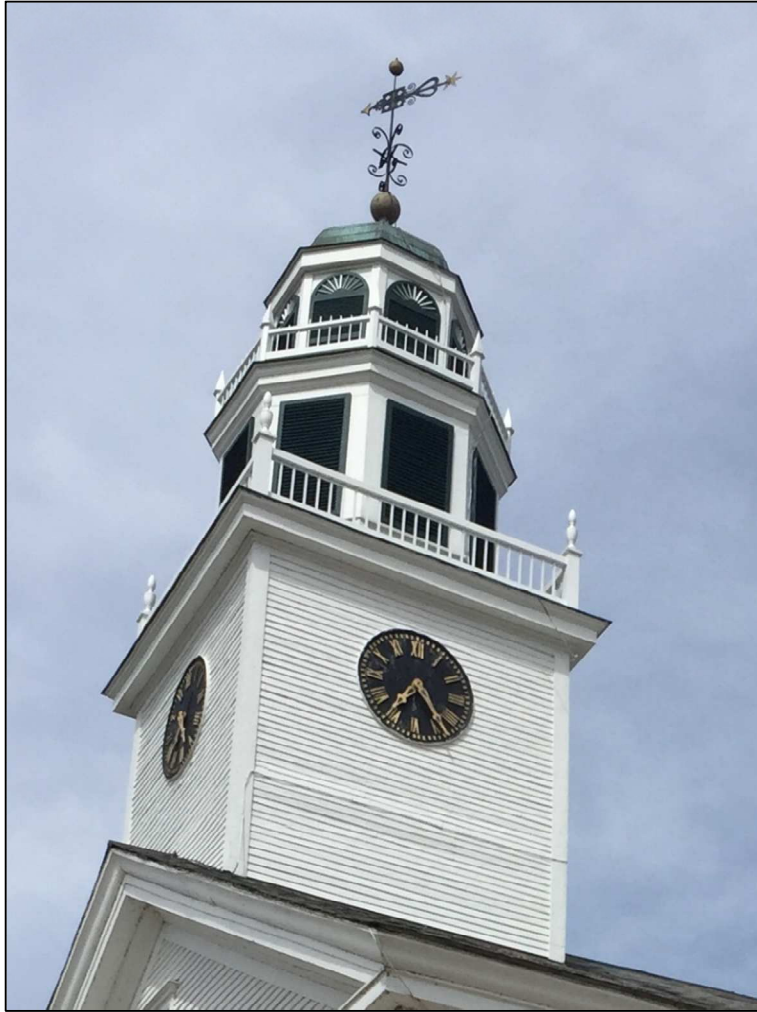
*Figure III-14: Bell Tower*

horizontal clapboards. Similar to the rest of the building, the clapboards and cornerboards are in good condition, with areas of paint chipping. Centrally located on the east, south and west faces of this volume, black clock faces with gold numbering and hands have been installed, edged in a simple, thin trim (Figure III-14). On the northern face of this volume, an original wooden, 16/16 double-hung window is located providing access into the clock room. This window is in fair condition but lacks thermal performance. Articulated trim and a flat-stock sill surround this window, with a more detailed header corresponding with the headers of the main entrance doors. From ground-level inspection and photography, these elements appear to be in fair condition.

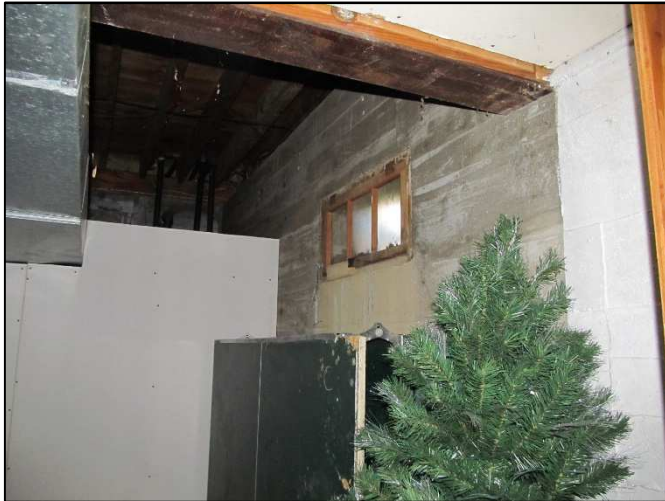
*Figure III-19: Storage Room, exposed structure & window*

A four paneled wooden door with mis-matched hardware, provides access to the storage room; however, this door has been removed from its hinges and simply rests within the opening. This room is partially finished, with shelving along the exposed eastern foundation wall. The vinyl tile flooring of the Community Room continues through this space and is in fair to good condition. Lighting fixtures within this space are minimal and do not work. There is evidence of some water damage throughout the

space, and the walls do not have baseboard; however, the gypsum board walls are new within the past two years. The mechanical ductwork that runs through the Community Room generating low clearance areas, continues through this space; however, the floor joists and structural steel beam are fully exposed in a portion of the space (Figure III-19). A glazed window is located on the eastern wall of this space, with glazing intact (Figure III-19).

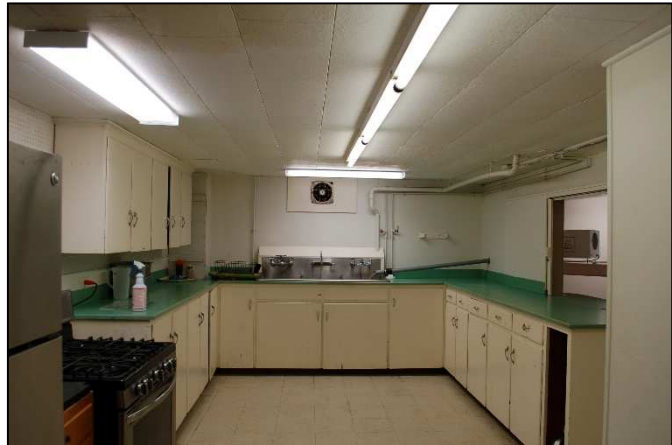
*Figure III-20: West wall of the kitchen*

range and the sink, providing adequate lighting for the space. In the southwestern corner of the room, a plywood plumbing chase has been constructed, housing the plumbing lines for the restroom above. This chase is in fair condition, but there are clear indications that this has been opened-up in the past. A single window opening is located above the sink; however, glazing is no longer present within the opening, as it has been filled with a vent (Figure III-20).

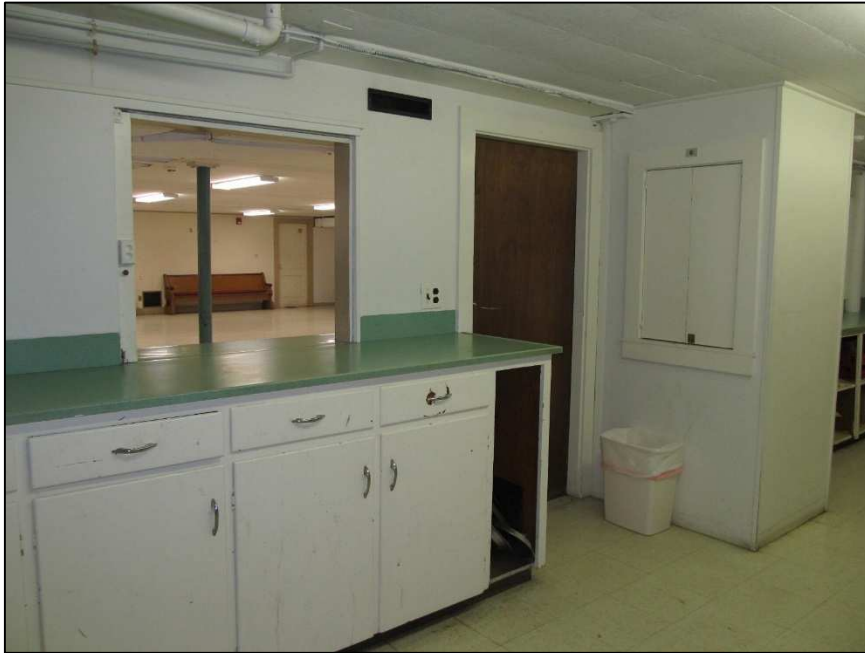
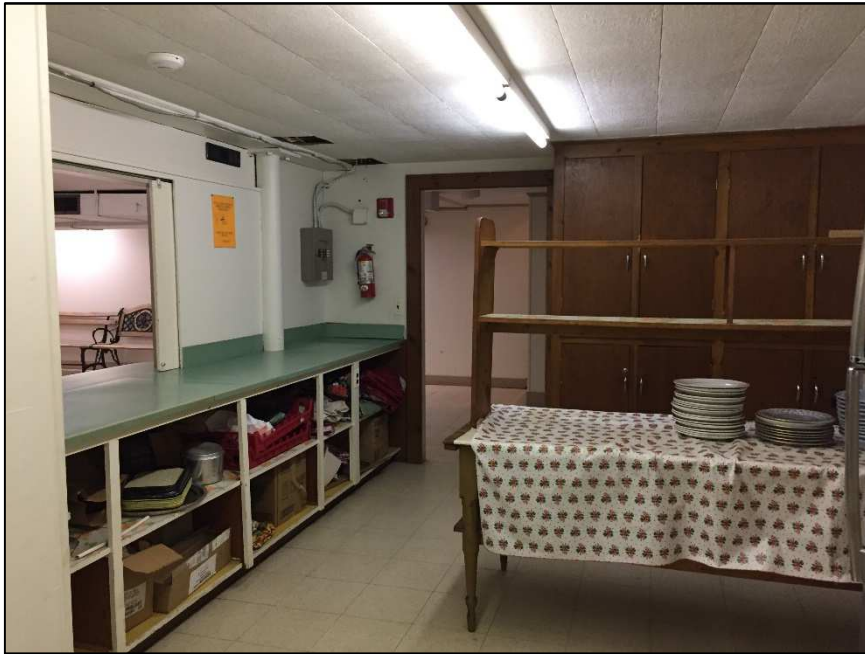
The kitchen is in fair to good condition; with functioning appliances and fixtures. Two, flat wooden doors provide access into the kitchen, with one on the northern wall and the other located on the eastern wall. Two pass-thru windows, with sliding panel doors, are located on the northern gypsum board wall, providing the direct connection into the Community Room (Figures III-21 & 22). Centered within

*Figure III-21: Western portion of the kitchen with dumbwaiter and access into the Community Room*

*Figure III-22: Eastern portion of the kitchen with storage and access into the Community Room*

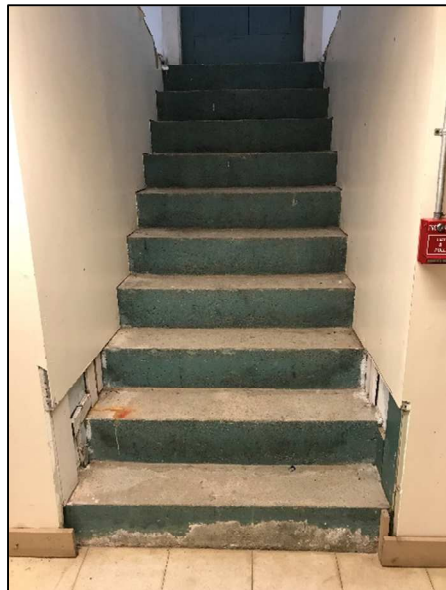
Figure III-27: Base of western egress

The western egress stair is in fair to poor condition, with areas of water damage, poor thermal performance, and no artificial lighting, further removing this stair from compliance with modern life-safety code. The concrete steps have unfinished concrete treads and painted concrete risers which are a ¼" taller than code allows. There are visible areas of water damage on the face of most of the risers, most notably the one at the

bottom which is in direct connection with the lower level floor, and there are stains on several of the tread surfaces (Figure III-27). The gypsum board walls of the Community Room wrap the corner of this opening; however, the base of the wall for the first two steps is not finished with furring and concrete wall exposed (Figure III-27).

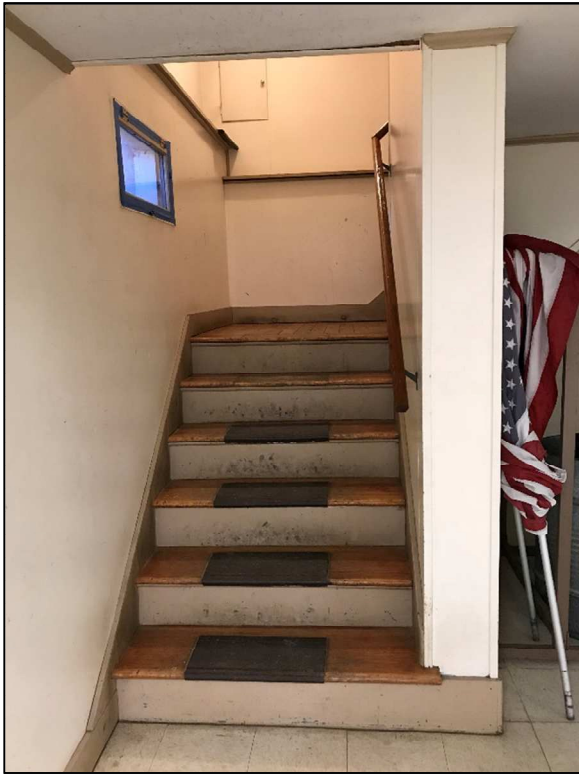
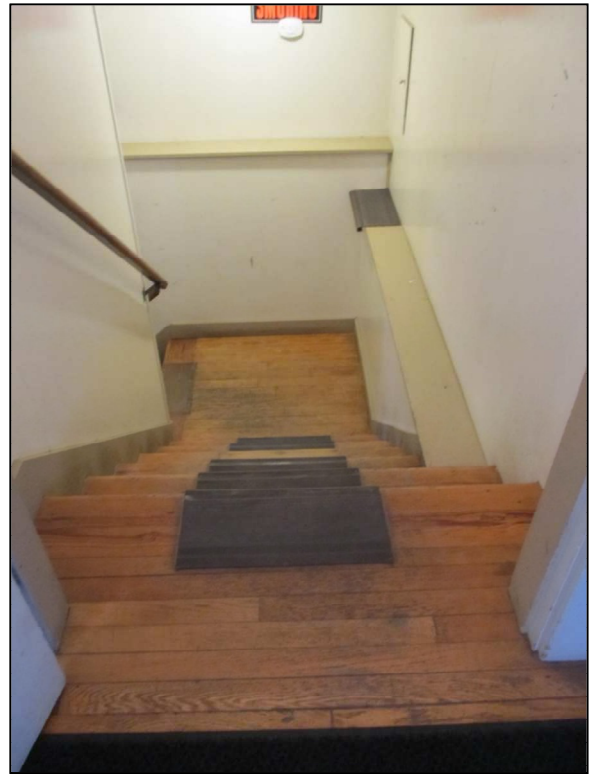
The stair is in good condition, with wooden treads needing a restoration, as there are areas of wearing from use. Centered on each step is a grooved rubber tread. These are in fair condition; however, they do not provide full coverage for the step, the express much wear and aging, and several are missing. Each painted riser has scuff-marks and some scrapes. A simple wooden rail has been installed on the interior walls of the stair and is in good condition. The wooden baseboard installed at the base of the walls throughout the Community Room, continue up through the stair, and are in good condition (Figure III-31). Two light fixtures provide adequate levels of lighting within the stairwell; however, they are not energy efficient. The stairs are enclosed as they enter onto the main level, and a six-paneled wooden door is located at the top of the stairs, opening into the Foyer.

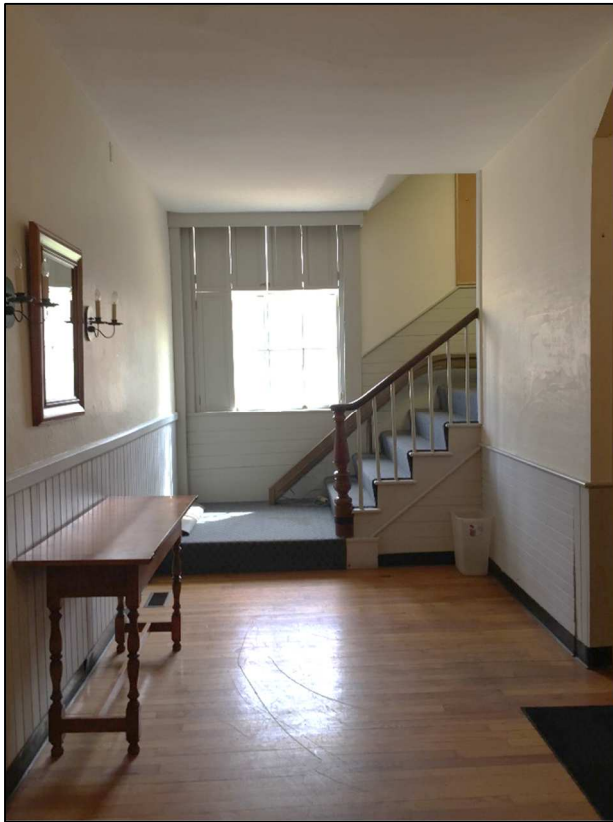
Figure III-32: Looking east within the Foyer

The Foyer is generally in good condition; the wainscoting on the north, west and south walls has a wide chair rail, vertically oriented beadboard and a modern vinyl baseboard (Figures III-32 & 33). On the eastern and southern walls of the enclosed staircase, a horizontally oriented beadboard wainscoting is located with a thin bead header and modern vinyl baseboard. The wainscoting has been painted but appears to be in good condition with minor scrapes and peeling. The painted plaster walls above the wainscoting are in good condition with minor cosmetic cracks and some areas where the texture of lathe below can be seen and felt. Installed

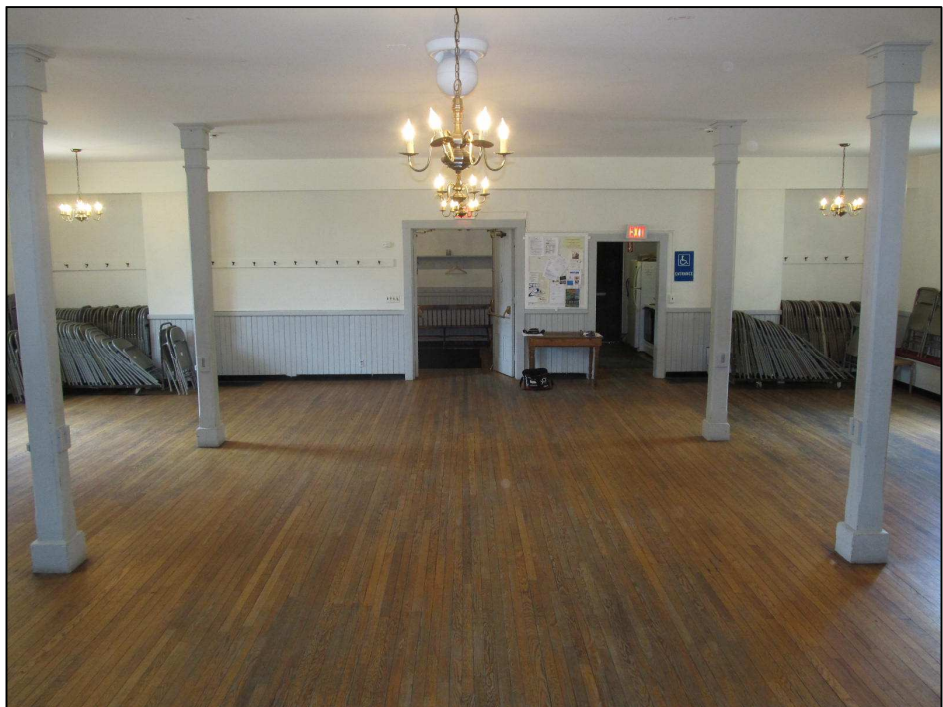
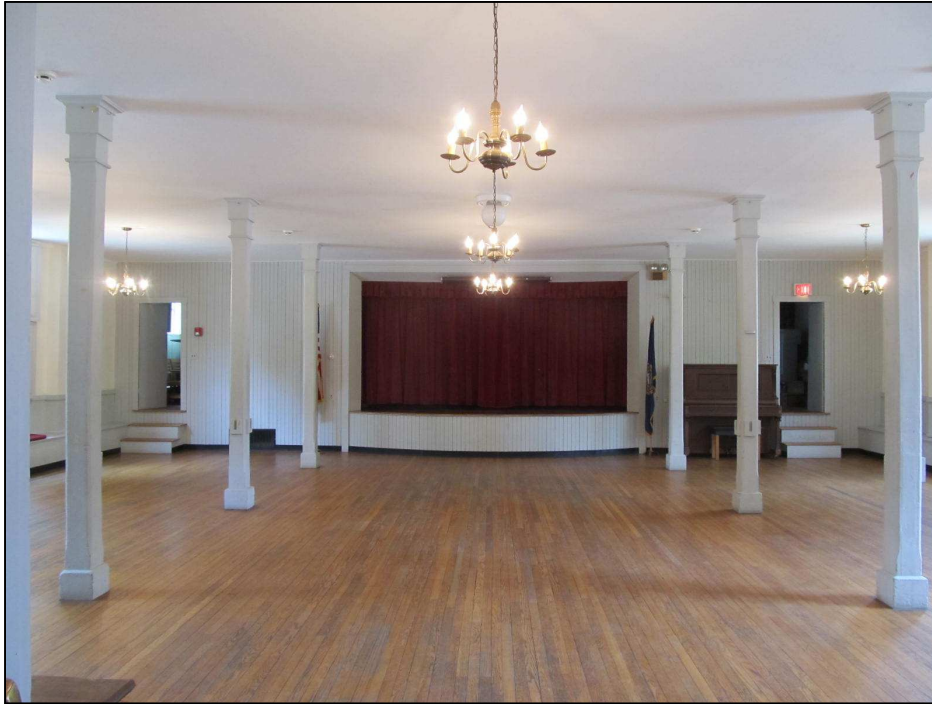
the Foyer, a thick wooden chair rail runs along the east, south and west walls, with painted plaster walls above. The plaster walls of the Meeting Hall are in good condition with minor areas of cosmetic cracking and deflection. The south wall has vertically oriented beadboard wainscoting integrated with the chair rail, with a modern vinyl baseboard (Figure III-

35). A cased opening on the southern wall of the Meeting Hall, adjacent to the Foyer doors, provides access to the kitchenette within the southwestern corner of the floor. The entire northern wall of the Meeting Hall surrounding the stage opening is beadboard, including the door panels on the left and right of the opening, which have been trimmed out with simple stock trim (Figure III-36). This beadboard is in good condition with minor areas of scratches, peeling and damage. The stage doorways express the most amount of damage with dings, chips and marks on its surface. The stage doors have basic early 20<sup>th</sup> century pulls installed on them to assist with their operation. A set of steps leads from the main elevation of the Hall onto the backstage area on either side of the Stage (Figure III-37). These steps are in good condition; however, their wooden treads are visibly worn.

however, there are areas that scrape against the plaster ceiling. The ceiling is in good condition with minor areas in need of repainting due to the shutters. Nine chandeliers provide lighting to the entire Hall and are centered within each of the structural bays (Figures III-35 & 36). These fixtures appear to be in good condition but are not energy efficient. The six structural wooden columns are in good condition; however, the faces of the posts showcase damage from use of the space, and modern wooden ‘saddles’ have been installed on each column, providing the ability to set-up the voting stalls (Figures III-35 & 36). Boxed framing posts are visible along the east and west walls (three on each wall), and have been integrated into the built-in benches. The heavy timber posts are plastered over and are in good condition. In general, the paint within this space could use refreshing, and should be evaluated for historic accuracy. The entire space is finished with a thin-board wooden floor with a light, natural stain that is in fair condition and needs to be refinished due to large areas of wear and use (Figures III-35 & 36).

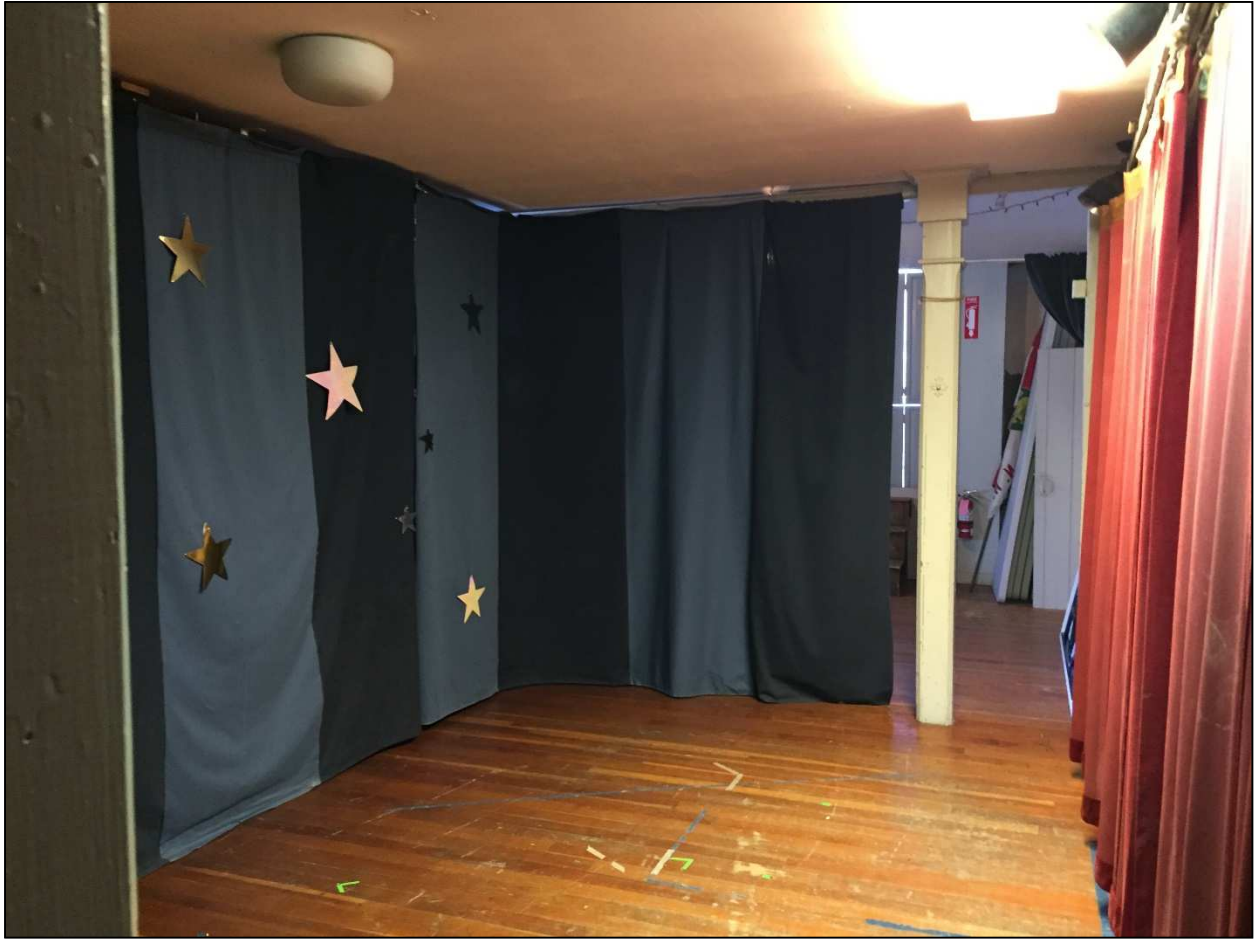
*Figure III-39: Stage looking northeast*

The entire northern portion of the main level is dedicated to the Stage (105), which is elevated approximately two-feet above the main level floor. The thin-board wooden floor of the Stage is in fair condition, as there are more scratches, damage and general wear from foot traffic and use (Figure III-39).

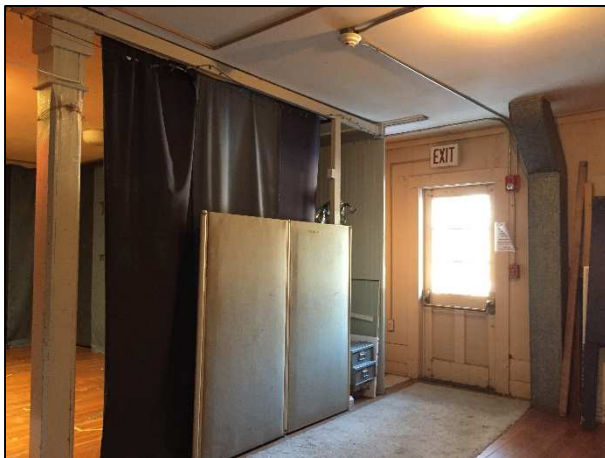
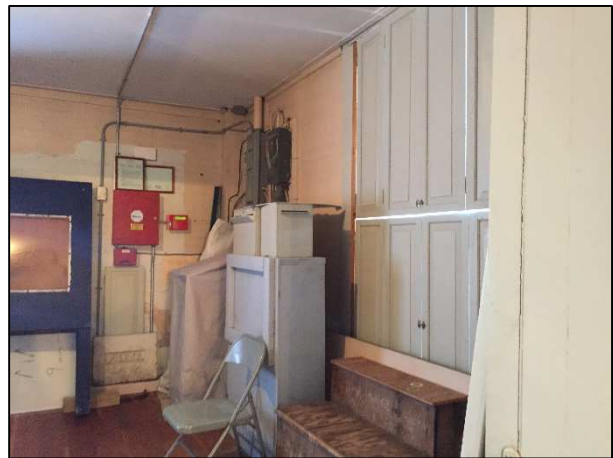
*Figure III-40: Eastern side of backstage*

*Figure III-41: Equipment and window backstage*

Overall, the exterior walls of the Stage are in bad condition. The plaster has come away from the lathe in several locations, there are areas of damage, paint peeling, unpainted patches, and mechanical and electrical equipment has been installed in various locations (Figures III-40 & 41). The center section of the northern wall, between the two doors leading to the Storage Room, is horizontal boards (Figure III-43). A thin

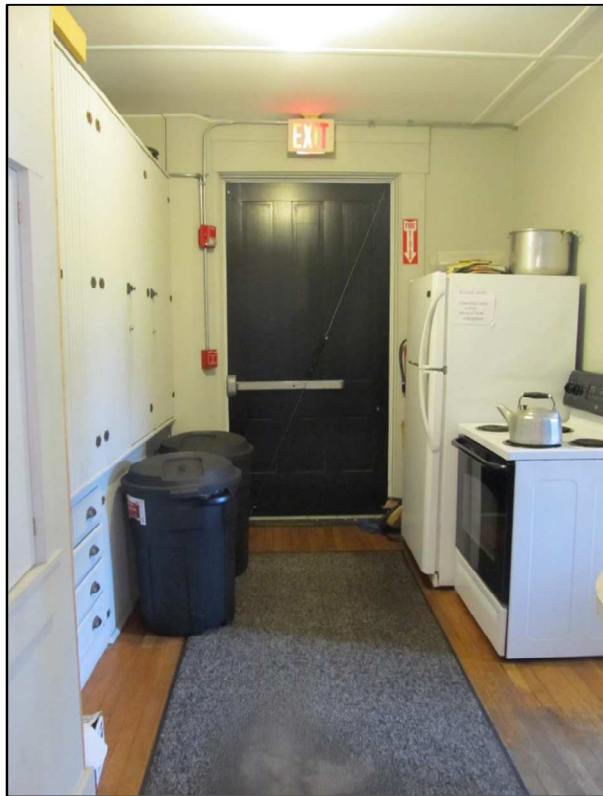
Figure III-46: Accessible entry through kitchenette

dumbwaiter have been installed along the entire eastern wall and are in fair condition (Figure III-46). The handicap accessible entrance into the building is located along the southern wall and is the second of the two main doors on the building's southern façade. This six-paneled wooden door has modern hardware on it and is generally in good condition (Figure III-46). A wooden baseboard wraps the space where built-ins are not located. Open-faced shelving with a thin veneer and wood countertop has been installed along the western and southern wall and are in fair condition with minor damage from use and age. Appliances are in fair condition. A large window is located above the counter on the western wall providing natural light into the space (Figure III-47). Though the window sash is in good condition, the exterior storm window is under-performing in energy

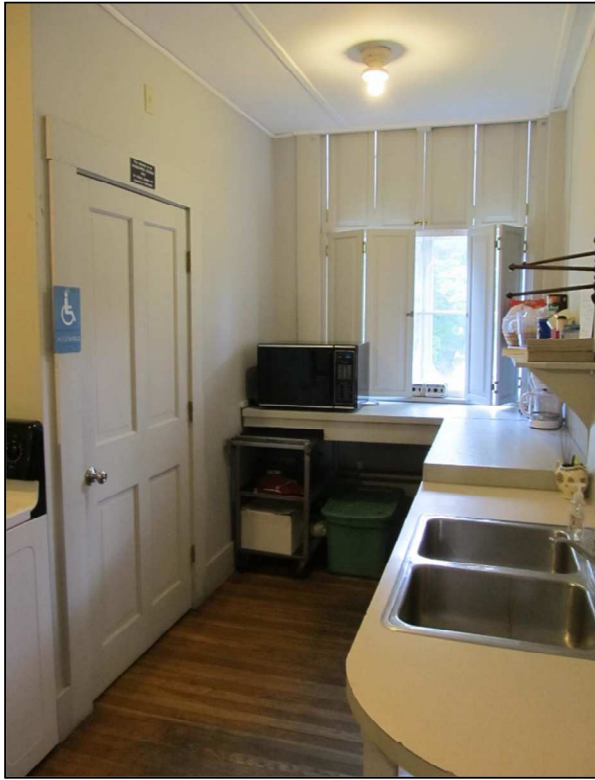
*Figure III-47: Kitchenette and accessible restroom*

efficiency. As with the other windows on this floor, there is a set of bi-folding interior shutters. The appliances on the counter prohibit the full operation of the lower portion of the shutter, and the top half of the shutter is entirely inoperable as it is bisected by the upper level floor. Two light fixtures are mounted on the plaster ceiling which is in good condition and has been divided up by decorative trim boards. These fixtures are not energy efficient and do not provide adequate levels of lighting. A four-paneled wooden door provides access from the Kitchenette to the Restroom (103) (Figure III-47).

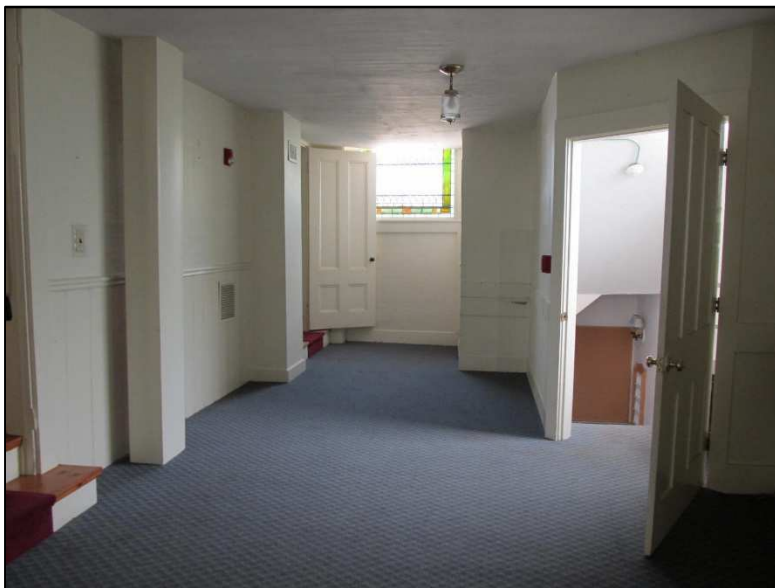
*Figure III-48: Narthex looking east*

The carpeted staircase leading from the main level has been enclosed at this level and is accessed via a six-paneled wooden door (Figure III-48). There are two south-facing large stained-glass windows at this level, one within the stair enclosure, and the other within the pastor's office. Both southern windows are in poor condition, with significant deflection at the bottom of the

The plaster walls and wainscoting of the Narthex and Pastor's Office are in good condition with minimal cosmetic cracks to the plaster (Figures III-48 & 50). A wide chair rail wraps from the central portion of the southern wall of the Narthex to the door enclosing the staircase leading to the Choir Loft (301) in the southeastern corner. This mid-19<sup>th</sup> century door is in fair condition, with large areas of scratches and paint peeling. The door has a mixture of historic door hardware with a modern automatic door closer, making the door difficult to operate. The north wall of the Narthex has a wide opening centered on the overall structure of the building, providing access into the Sanctuary (Figure III-51). Two stained wooden steps with a central carpet runner, lead from the Narthex floor to the Sanctuary floor, and are in good condition. Grab bars have been

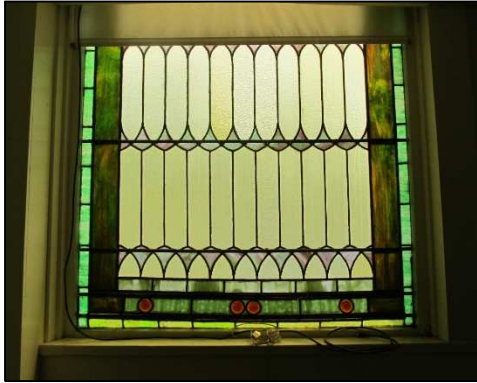
*Figure III-49: Typical stained-glass window*

sash, cracked or broken glass, cracks within the perimeter leading, and a majority of the tie wires have pulled away, rendering the horizontal support bars useless (Figure III-49).<sup>1</sup> Two additional stained-glass windows are located within the 1867 addition (southern bay): one on the east wall within the Narthex and one on the west wall within the Pastor's Office. These additional windows are in fair, structurally sound condition, with minor areas of deflection, cracked or broken glass, cracks within the perimeter leading, and a majority of the tie wires have pulled away, rendering the horizontal support bars useless. All four of these windows are bisected by the floor of the Choir Loft above, leaving the lower portion of the glass visible at this level, and the upper sash visible from the choir loft above (301) (Figure III-49). The plaster ceiling of both the narthex and pastor's office is

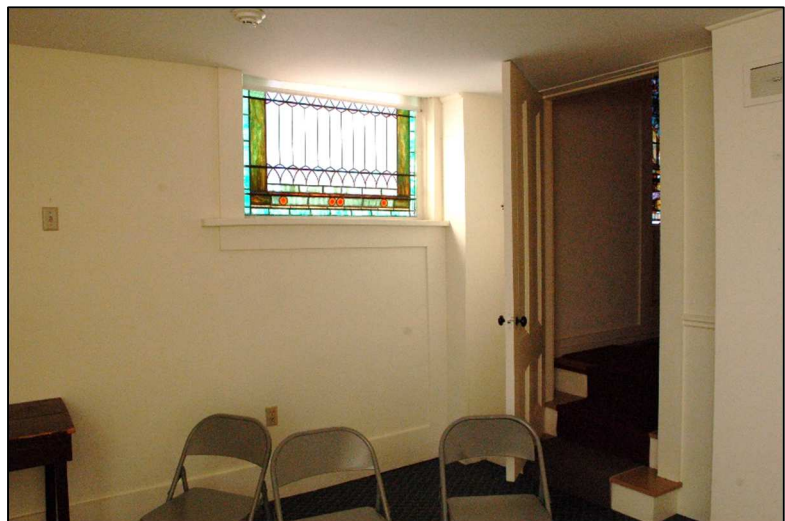
*Figure III-53: Pastor's Office*

The Pastor's Office, located to the west of the Narthex, is accessed through a set of four-paneled wooden double-doors that are in good condition (Figure III-50). There is no threshold between the two spaces. There is a four-panel wooden door in the northwest corner of this space, providing an access point into the Sanctuary (Figure III-53). This door matches that in the northeast corner of the Narthex with the exception that the central carpet runner does not match the carpet within the Sanctuary. Along this northern wall, there are two rectangular plaster enclosures within the vertical plane of the wall with a built-in bookcase constructed between them. The eastern enclosure contains the northwest post of the Bell Tower. The western enclosure contains mechanical ductwork.

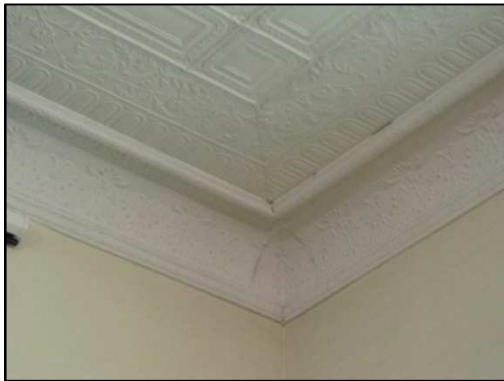
*Figure III-54: Steel crown molding*

The Sanctuary (203) has a painted, stamped tin ceiling with matching crown molding that is nearly twice the height of the Meeting Hall below. The ceiling is in good condition, despite having a fair amount of dust on its surface, with a few areas of water damage and rust (Figure III-54). Four chandeliers and four ceiling fans have been installed within the ceiling, as well as a central globe fixture that is part of the space's A/V equipment. The fixtures are in good condition but are not energy efficient, and provide adequate lighting to the space, with minimal dark spots (Figure III-55). A red carpet runner is installed along the aisles of the room and atop the entire altar platform. This carpet is in fair condition with some soiled and worn out areas. Twenty-two wooden pews are organized in rows within the space, generating small aisles along the exterior walls and a large central aisle running north to south and leading to the altar (Figure III-56). These pews are in good condition; however, because they were added at a later date, they do not match in wood type or finish the remainder of the wooden details and elements at the Altar.

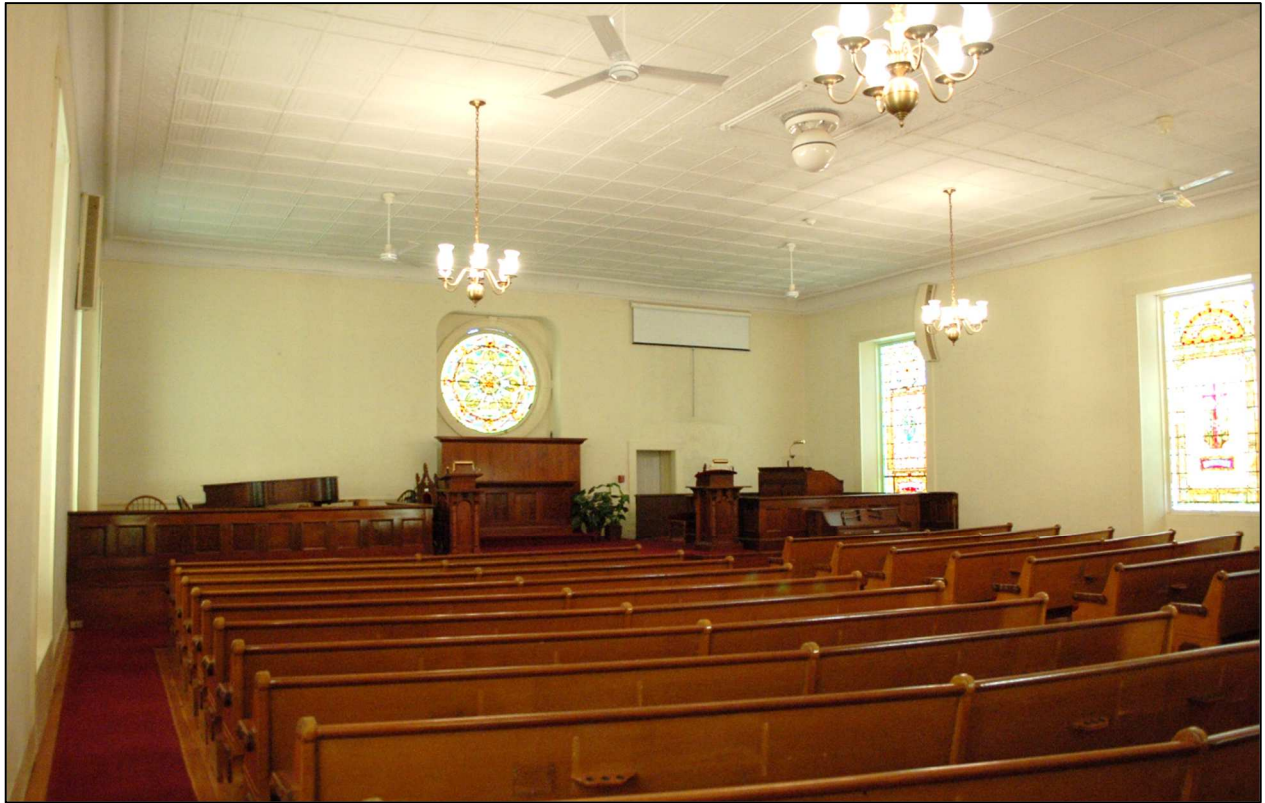
Figure III-57: Sanctuary looking north towards Altar

The Organ, located within the eastern portion and the Choir, located within the western portion, with the altar and two lecterns centered below the circular stained-glass window (Figure III-57). Low mahogany paneled walls boarder the Choir to the south and east and the Organ to the west, south, east and north, as the raised Altar platform does not physically connect with the eastern wall and a portion of the northern

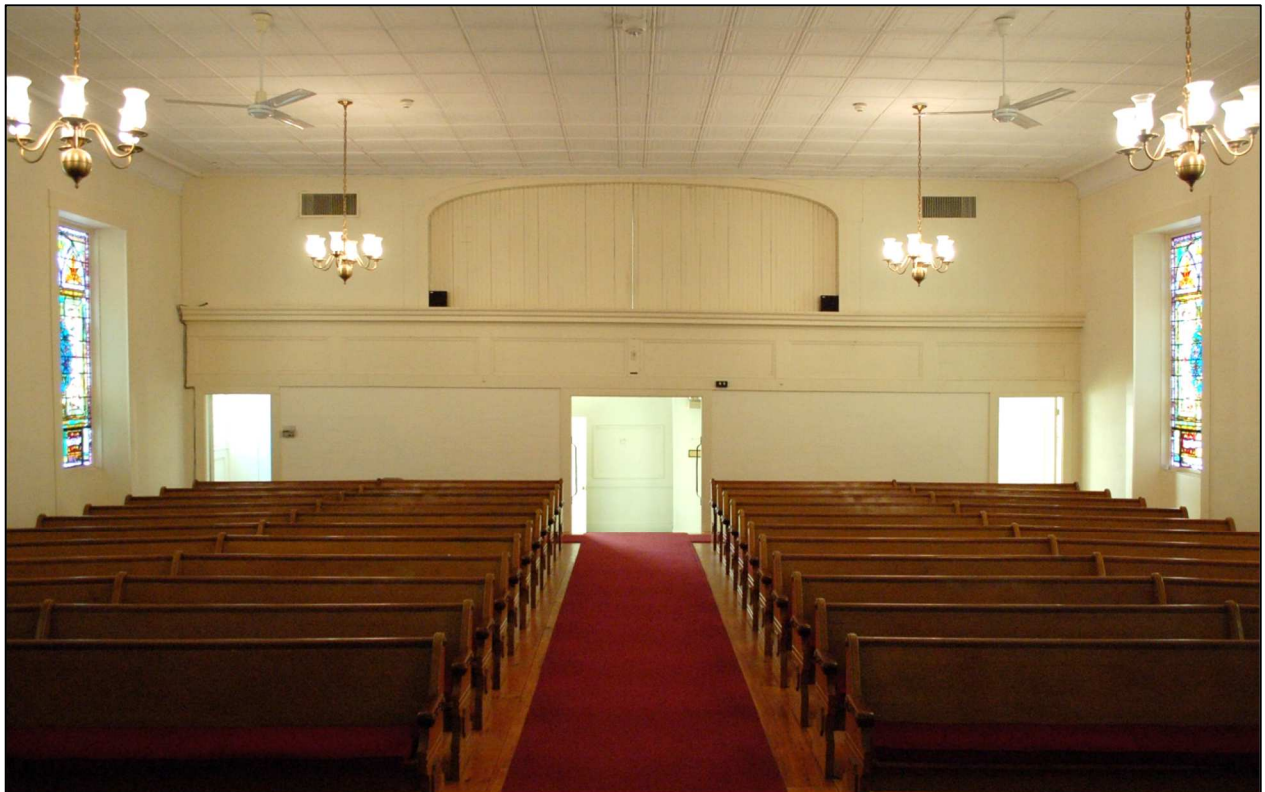
Figure III-58: Sanctuary looking south towards Narthex and Choir Loft

cased opening in the center, a single door to the west, and a large opening to the Choir Loft (301) at the center of the wall, directly above the double door (Figure III-58). The lower portion of the wall is modern gypsum board, painted white with flat stock trim at each of the doors. Above each door header and running the length of the wall is a paneled belt-belt-course on top of which is an articulated molding profile that caps the low wall of the Choir Loft opening. The remainder of the upper wall is plaster that matches in condition to the rest of the walls within the space, with cosmetic cracks and uneven surfaces, and two mechanical vents located on either side of the cased loft opening. Within the opening are sliding, vertically oriented beadboard panels that have no hardware and appear to need some repainting.

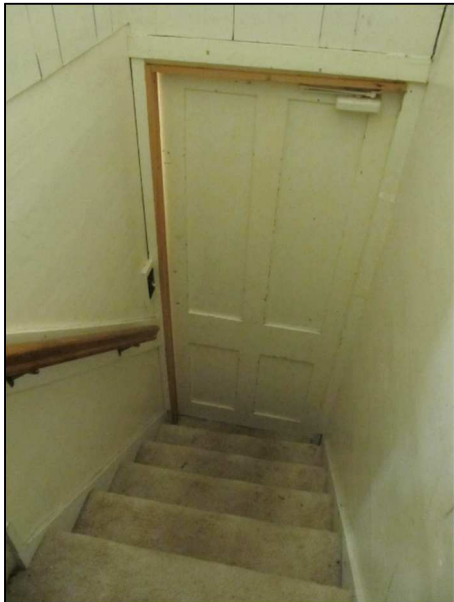
*Figure III-63: Stairway to Choir Loft*

A set of steep, carpeted stairs from the upper level is the only means of access to the space (Figure III-63). This stair, wrapping the southeastern corner, has mixed vertical board and plaster walls along its inside corner with a wooden handrail installed on a flat stock trim board, that are in fair condition with minor damage, peeling paint and cosmetic cracks. A beaded chair rail bisects the vertical boards on the stair side, with boards above and below not aligning with each other. The vertical boards become a partial height wall capped with a curved rail with bookshelves installed against it within the Choir Loft (Figure III-64). The carpet on the

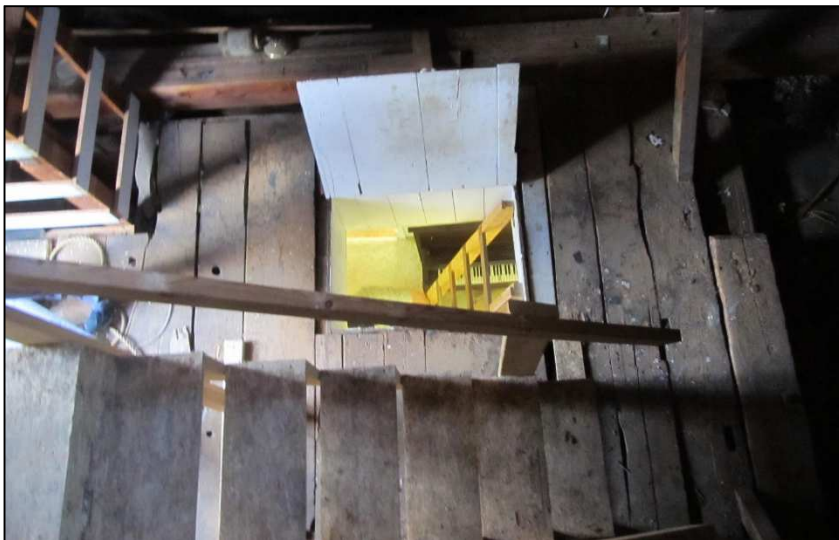
*Figure III-77: Attic floor*

The floor of the tower section is comprised of wooden planks is in poor condition, with major soft spots, sagging and broken boards. Integrated into the floor is the hatch door that provides access into the space

from the loft level (Figure III-77). There are no railings installed at the perimeter of the floor space, which is a major safety hazard as the floor joists and ceiling below are exposed and would not support any weight on them. Modern stairs have been constructed that provide access to the Clock Room; these stairs have railings and are well constructed (Figure III-78). A platform extends from the landing of the stairs, south and connects with the southern wall of the building. Atop this landing, a ladder is located that provides access

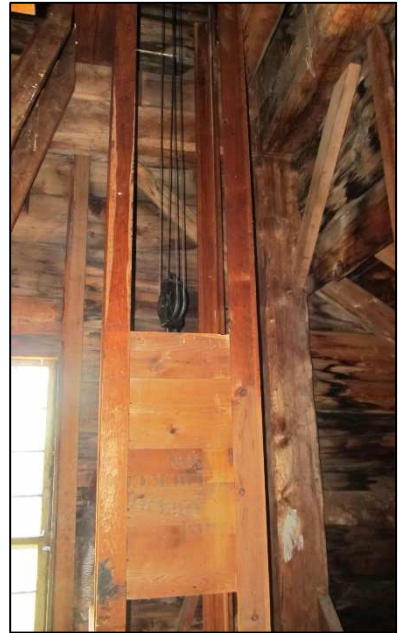
*Figure III-79: Western counterweight*

to the Bell Tower. Both the landing and the ladder are in fair condition but are in need of some improvements. Centered below the Clock Room above, and hanging into this space, an enclosure of horizontal boards has been created that houses the clock's pendulum, protecting it from any potential hazards. There are two partial enclosures located along the southern wall that relate to the clock's counter-weight system (Figure III-79).
