# **Historic Building Assessment for the Greenfield Meetinghouse**

**776 Forest Road, Greenfield, New Hampshire**

Mae H. Williams, Preservation Consultant & Misiaszek Turpin pllc

February 2019

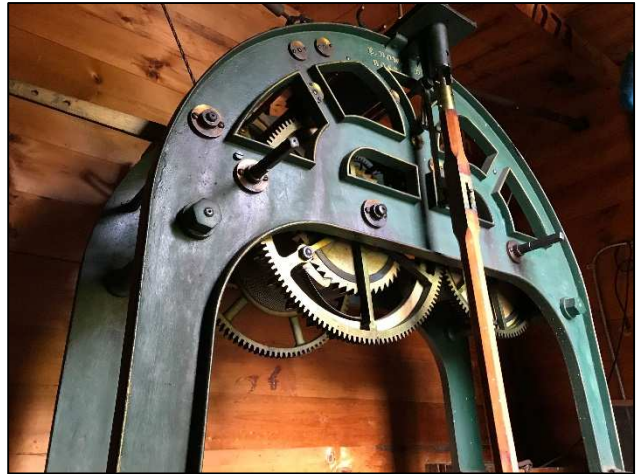
Figure III-80: Clock mechanicals

The Clock Room is generally in good condition (Figure III-80). This space is accessed through a hatch in the floor, and is centered within the Bell Tower itself (Figure III-81). The room contains the mechanical system of the clock, which is in good working condition. A modern set of stairs constructed within the Attic lead to this hatch; however, due to space constraints, a partial vertical ladder had to be constructed towards the top of the stairs to provide full access into the Clock Room. The plank wood flooring is in good condition with minor use marks and scratches. The thin horizontal board walls are in good condition and have a door integrated on the north wall of the room that opens and provides access to and light from the north-facing double-hung window (Figure III-82). This

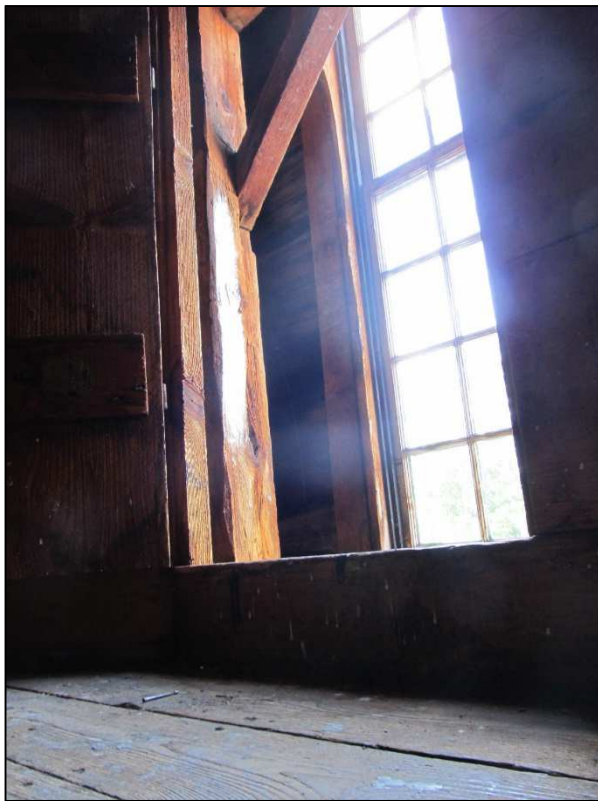
Figure III-82: Clock Room window

window is in fair condition for its age; however, it has no hardware. Along the walls are areas of graffiti done over the years marking significant dates, times of construction and people. There is a single lightbulb illuminating the space.

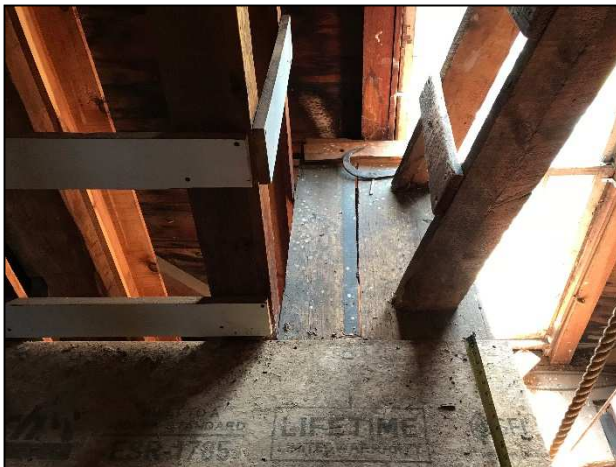
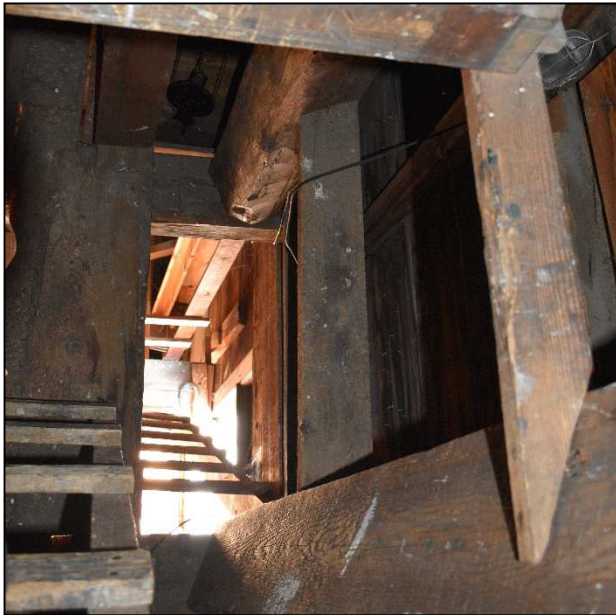
access to the volume of the Bell Tower from which, access to the Belfry is located. Space is very limited with these ladders, resulting in side-stepping and narrow climbs, with no supports (Figure III-84 & 85). Both ladders are in fair condition, but are in need of improvements, providing increased safety and accessibility for maintenance. The northern window also provides natural light into this space; however, the space remains very dark and difficult to see as there is no artificial lighting. Large timber columns and beams are visible within this volume and provide structure for the Belfry above. A small, triangular landing has been installed at the top of the second ladder, from which the ceiling hatch to the Belfry is accessible (Figure III-86).
